**THE CALIFORNIA DEPARTMENT OF FOOD AND AGRICULTURE
HYDRILLA ERADICATION PROGRAM
ANNUAL PROGRESS REPORT 2012**

Prepared by Patrick Akers, Supervising Scientist,
with the assistance of Program Staff

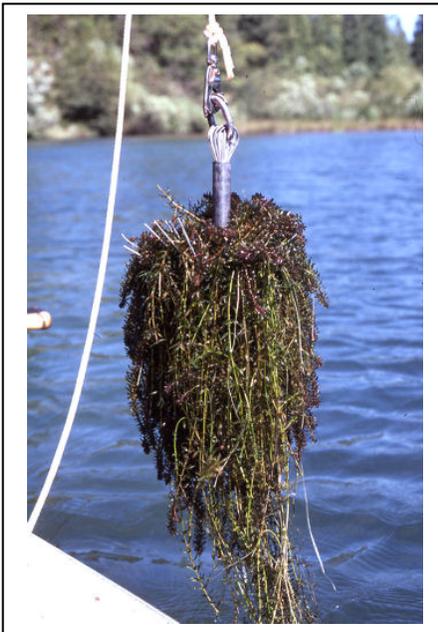
Plate 1. The “hydrilla hook”, a small grappling hook, with hydrilla

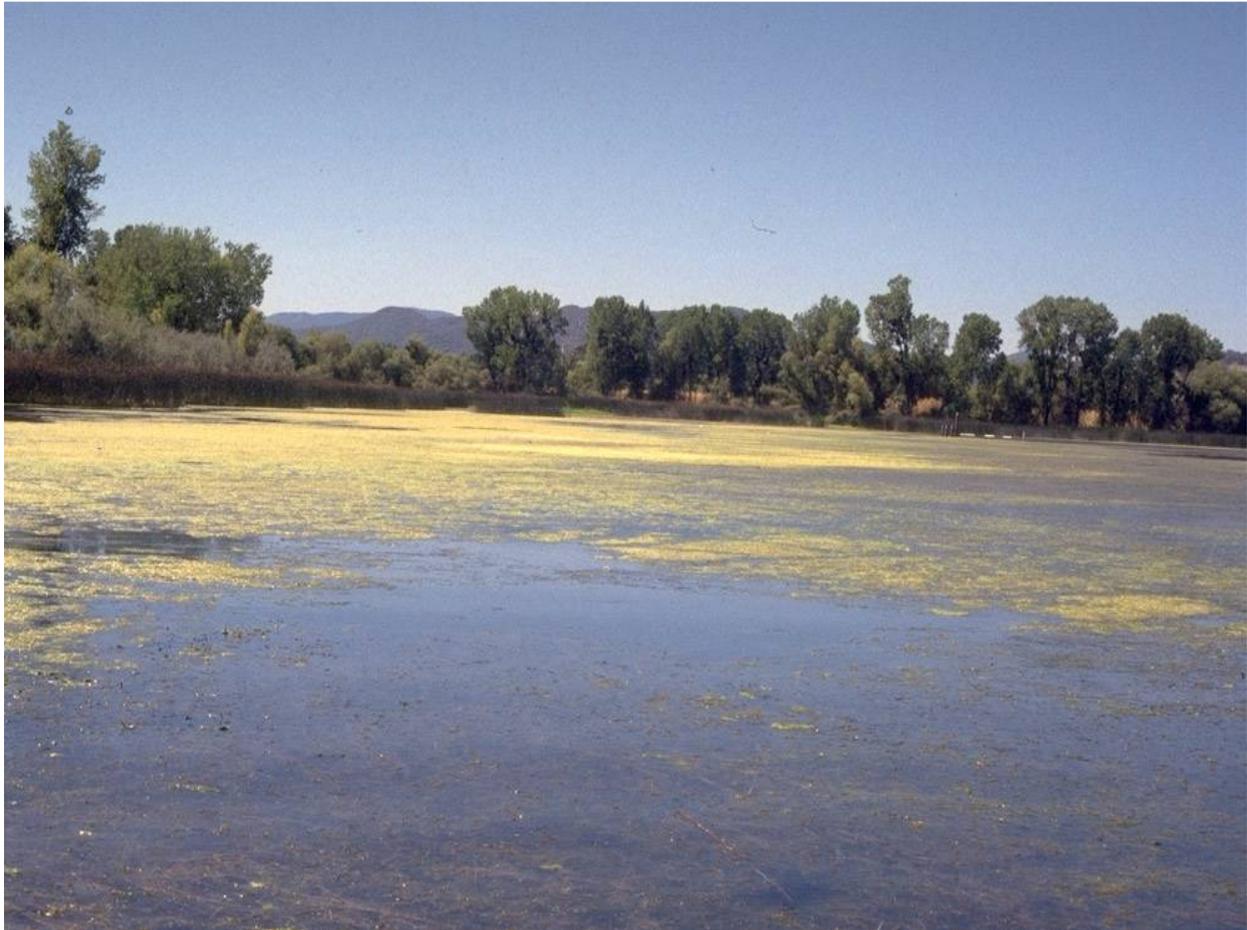
Plate 9: Hydrilla in Clear Lake, 1994, in the area of Big Valley, before treatments started.

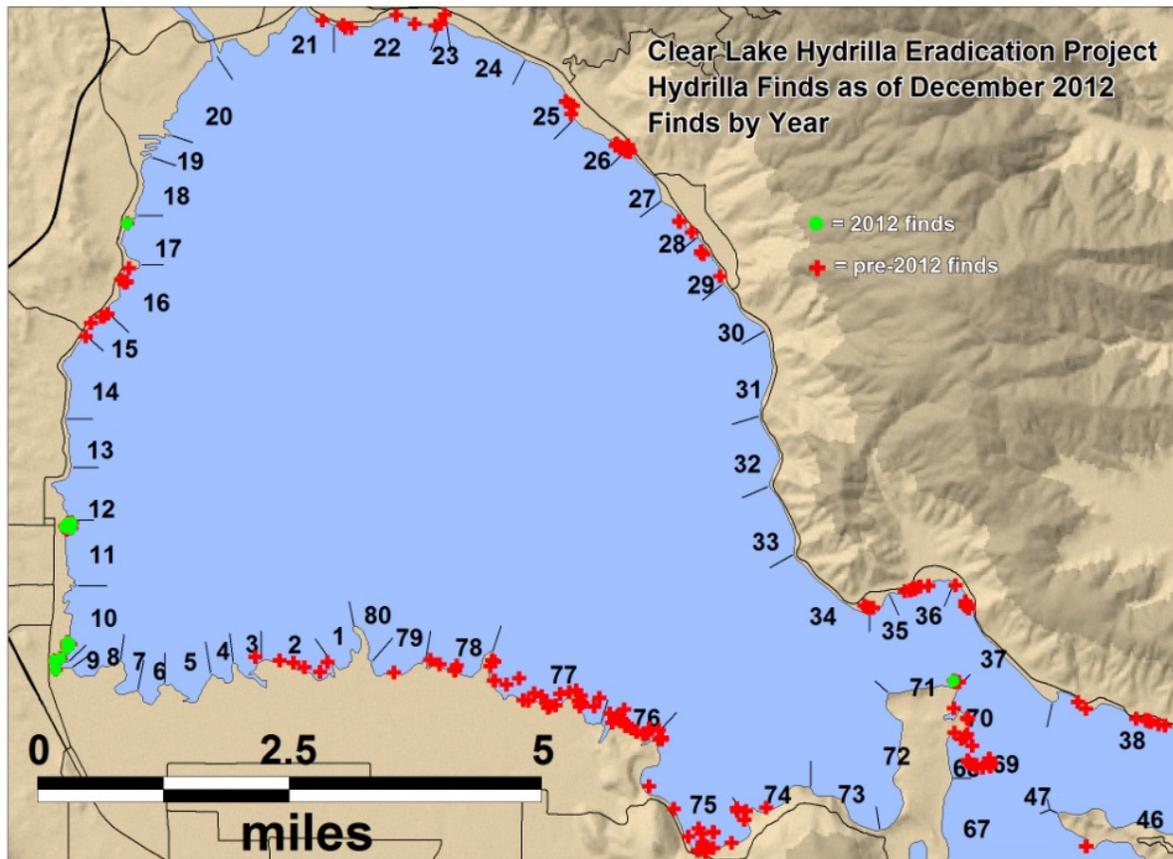
Plate 14. Hydrilla finds in 2012, whole lake
