‘THE CALIFORNIA DEPARTMENT OF FOOD AND AGRICULTURE HYDRILLA ERADICATION PROGRAM ANNUAL PROGRESS REPORT 2006

PROTECTING CALIFORNIA’S WATERWAYS

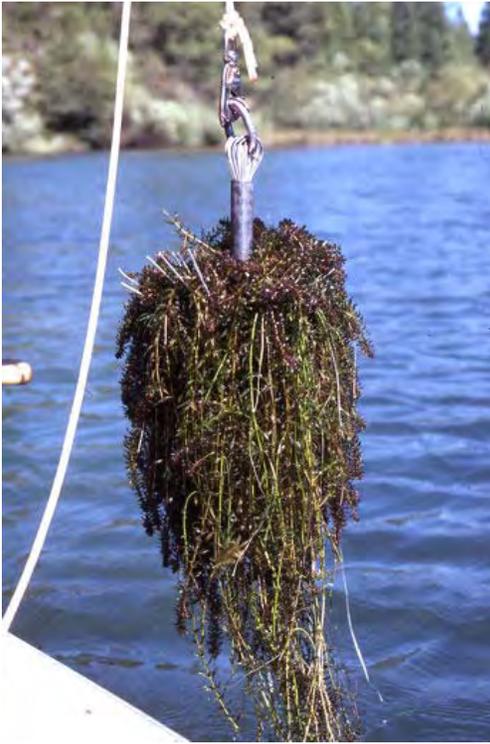
Plate 1. The "hydrilla hook", a small grapple hook, with hydrilla

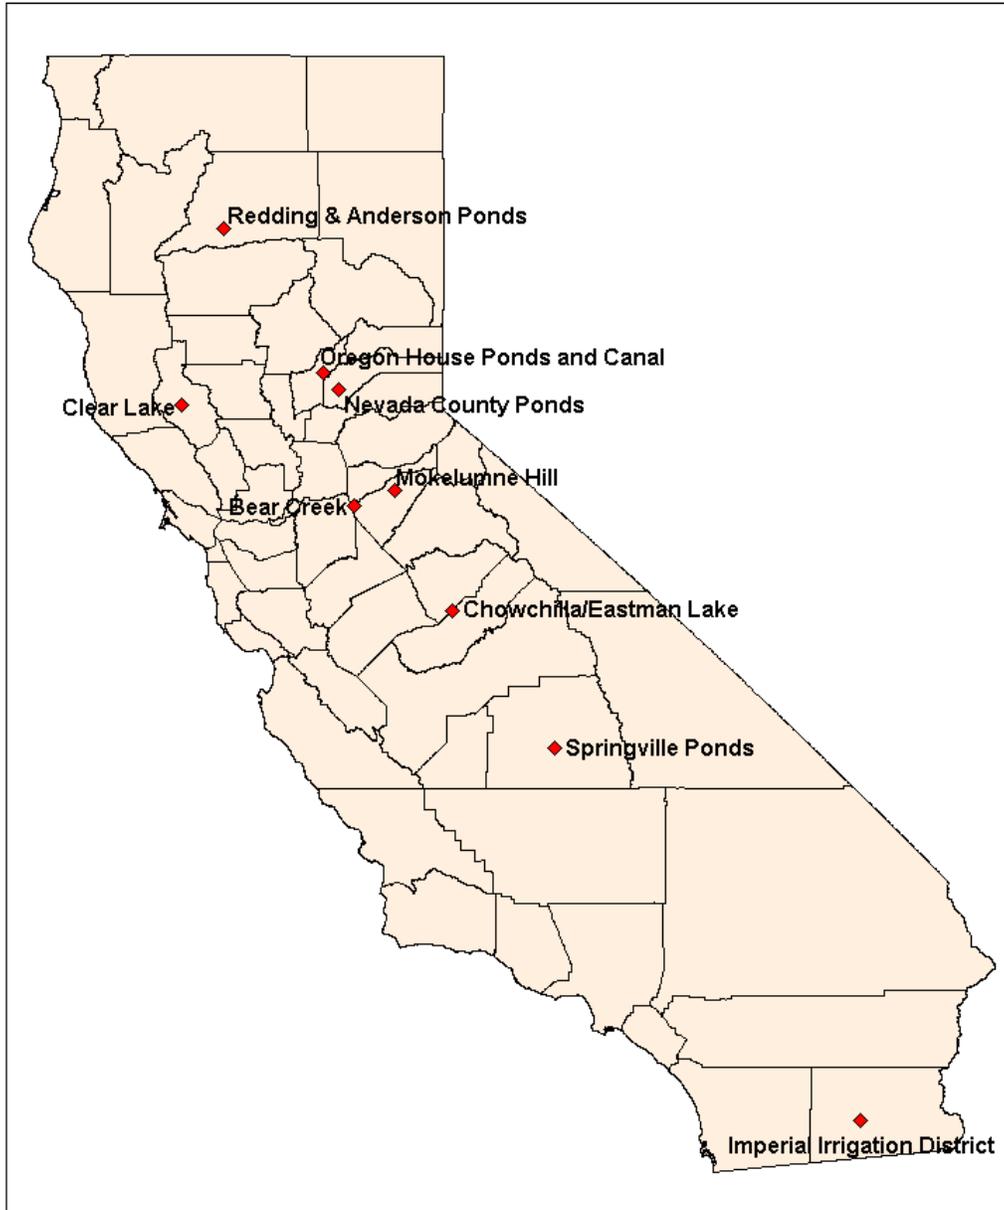
California Department of Food and Agriculture Current Hydrilla Eradication Projects, 2006

The status of all current and historical sites in the Hydrilla Eradication Program is summarized in Table 1 and Plate 2.

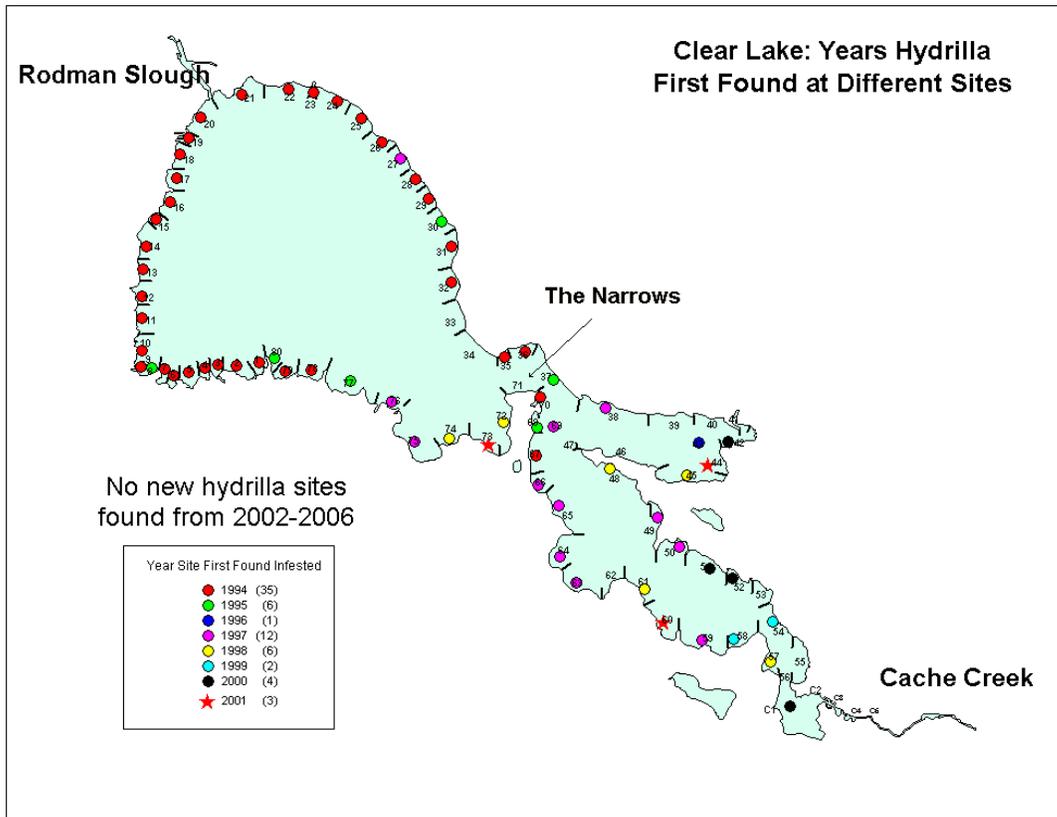
Plate 5. Map of Clear Lake in Lake County Showing Location of Hydrilla Program Management Units and the Year Hydrilla First Detected in Each Unit.

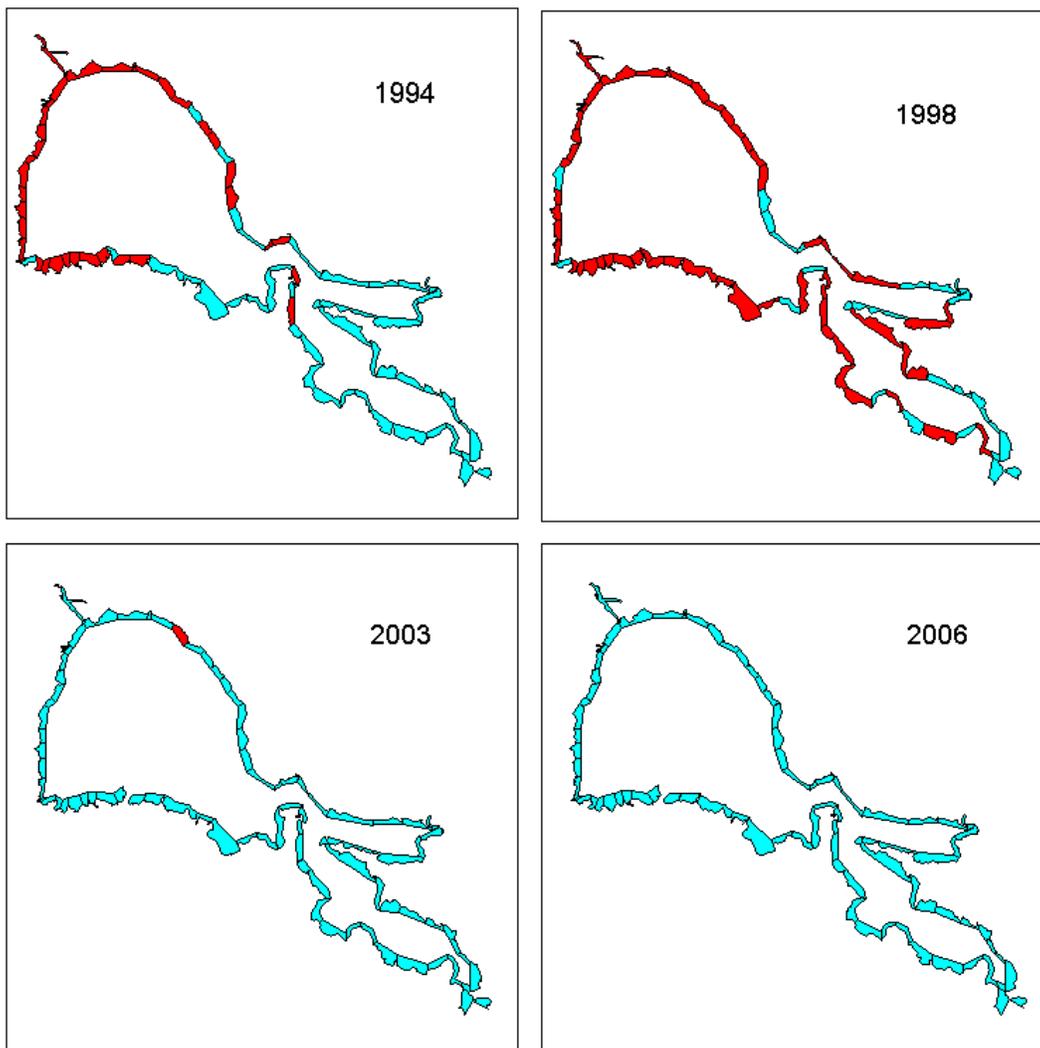
Plate 6. The Change in Hydrilla Infestation in Clear Lake from Year of First Detection in 1994, to 2006.

Yearly Survey Results, Clear Lake Hydrilla Infestations, 1994-2006

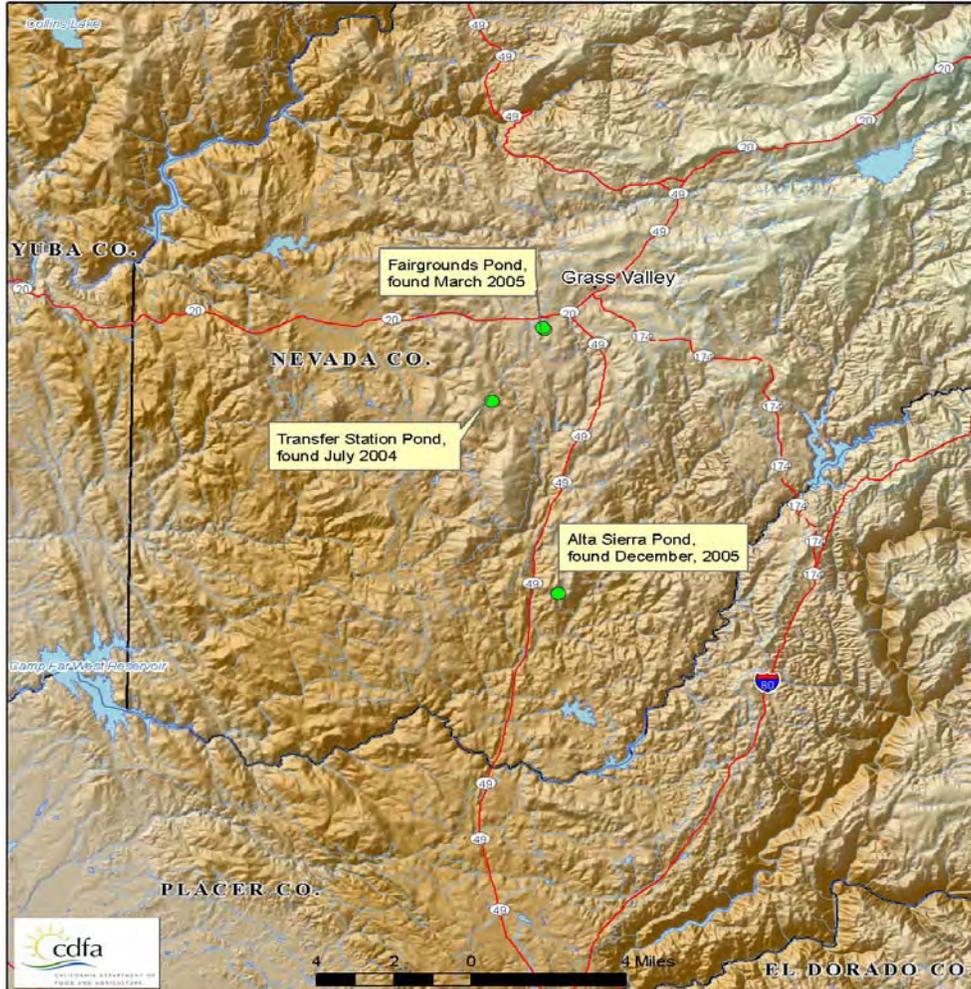
Plate 7. Map of Hydrilla Infested Pond Currently Known to be Infested in Nevada County.

**California Department of Food and Agriculture
Recent Hydrilla Detections in Nevada County, 2005**

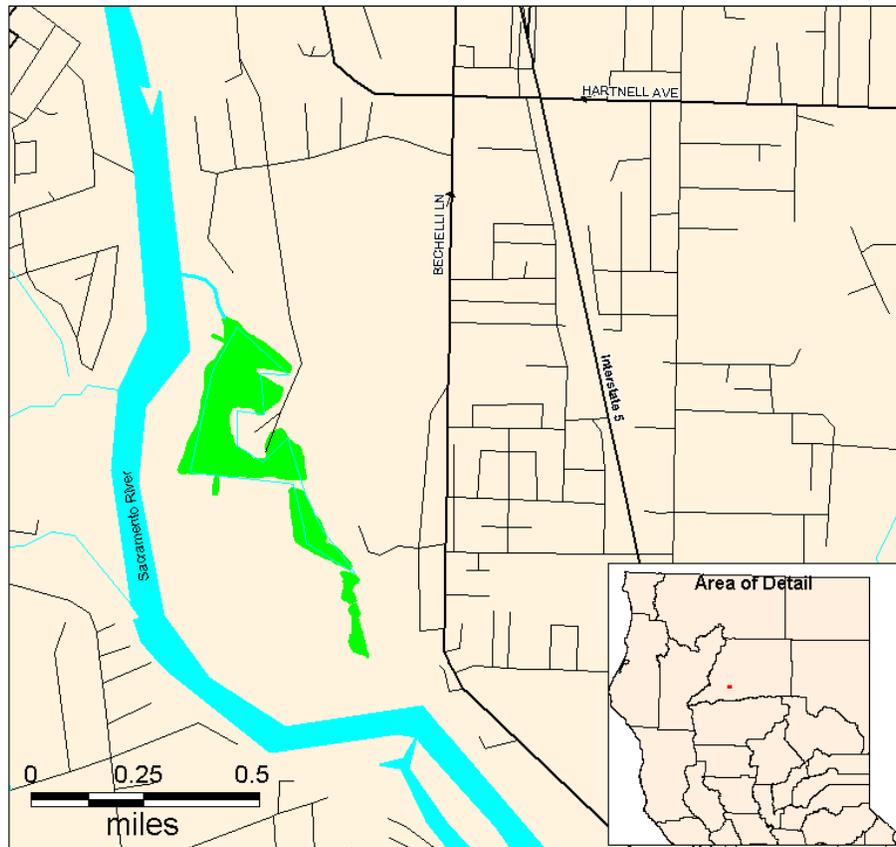
Plate 8. Map Showing Infestation at Riverview Golf Course, Redding.

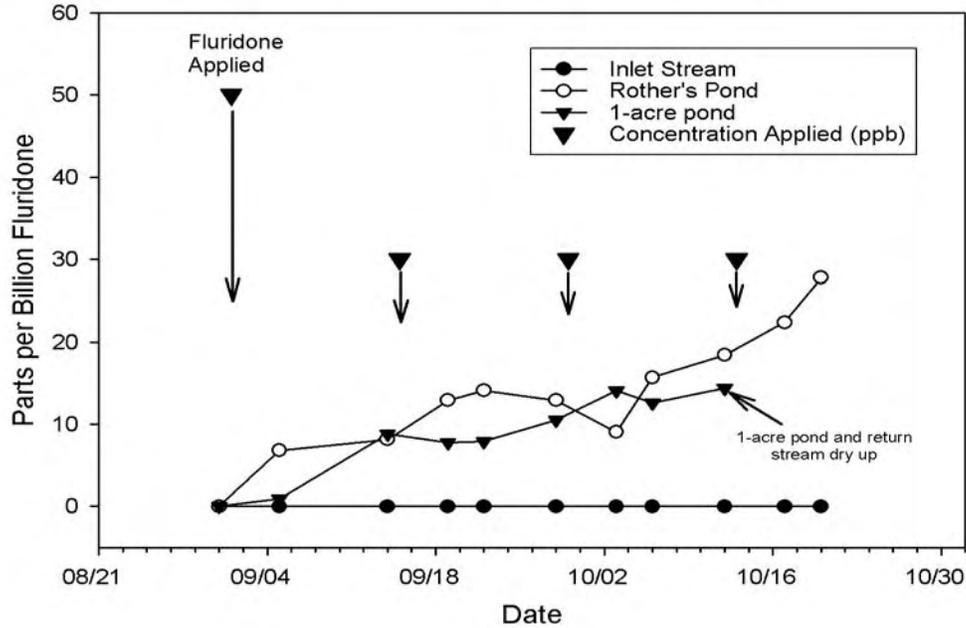
Plate 9.

Fluridone Concentrations at Different Sampling Stations in the Riverview Golf Course Pond System

Starting in late July and for most of the treatment season, the Riverview Golf Course pumped irrigation water from the Sacramento River in order to avoid using fluridone treated water from Rother's Pond³¹.

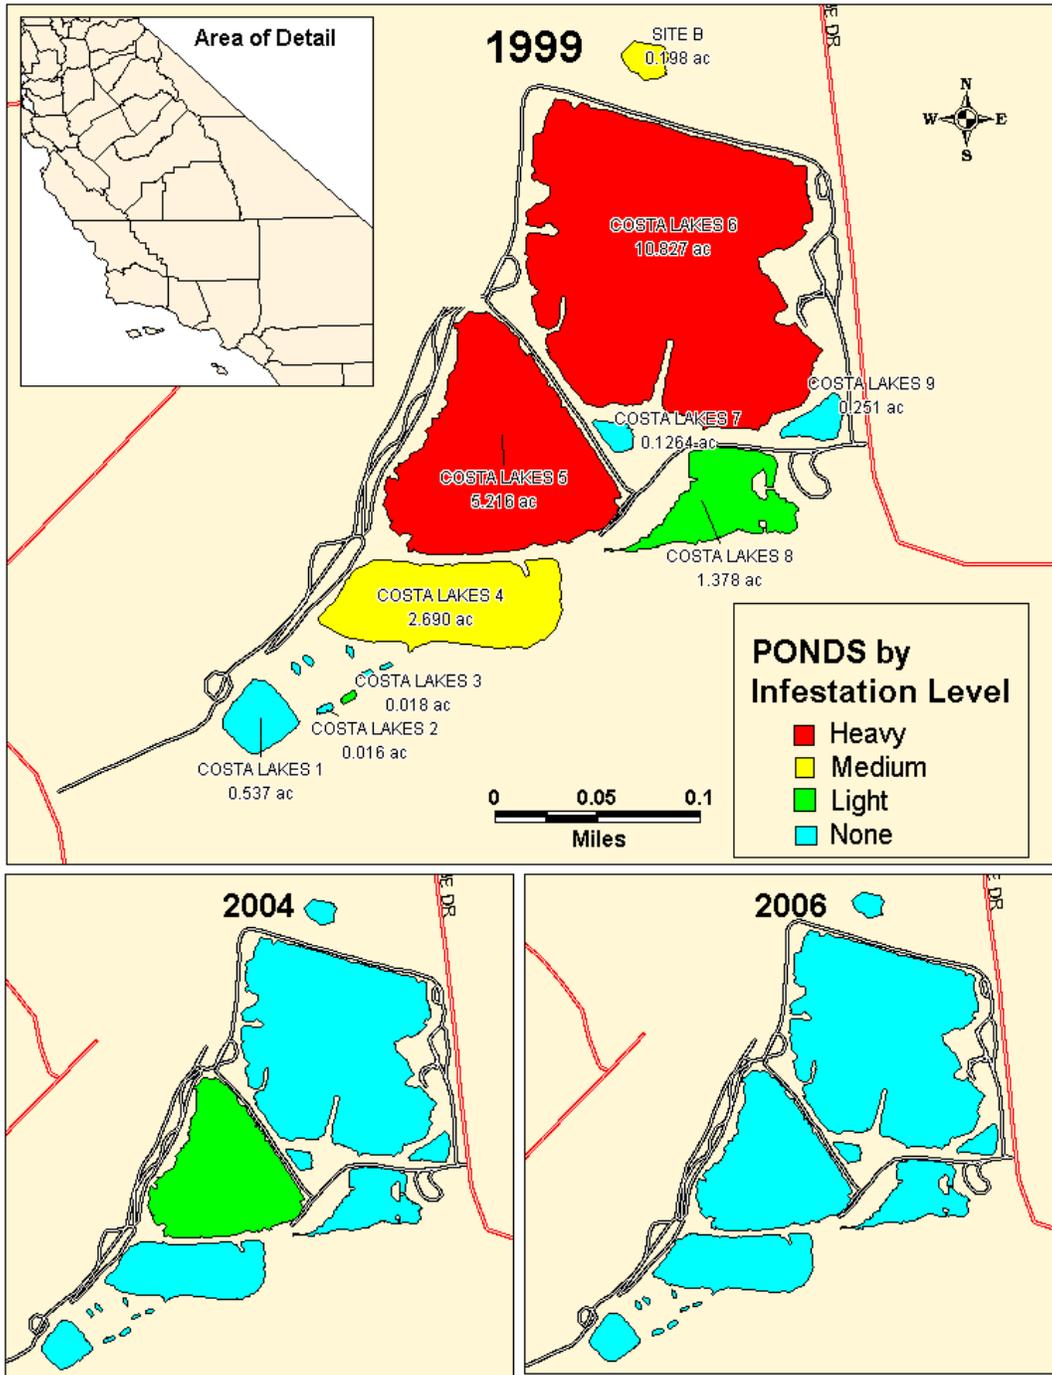
Plate 10. Map Showing Change in Hydrilla Infestation at the Springville Ponds from the Year of First Detection, 1996, to Current Year, 2006.

Delimitation surveys by project crews determined that five ponds were infested on the resort and one pond was infested on an adjacent, downstream property. The infested ponds ranged in size from 0.02 acres to 10.8 acres with a total surface area of all ponds being 20 acres (Plate 10). The infestations in the ponds ranged from very dense to just a few scattered plants. Four other non-infested ponds were also on the resort's property. Additional ponds have been created since the initial hydrilla detection. Most of these are relatively small (less than 0.1 acre) and are used for fish breeding. There are now a total of 15 ponds on the resort property.

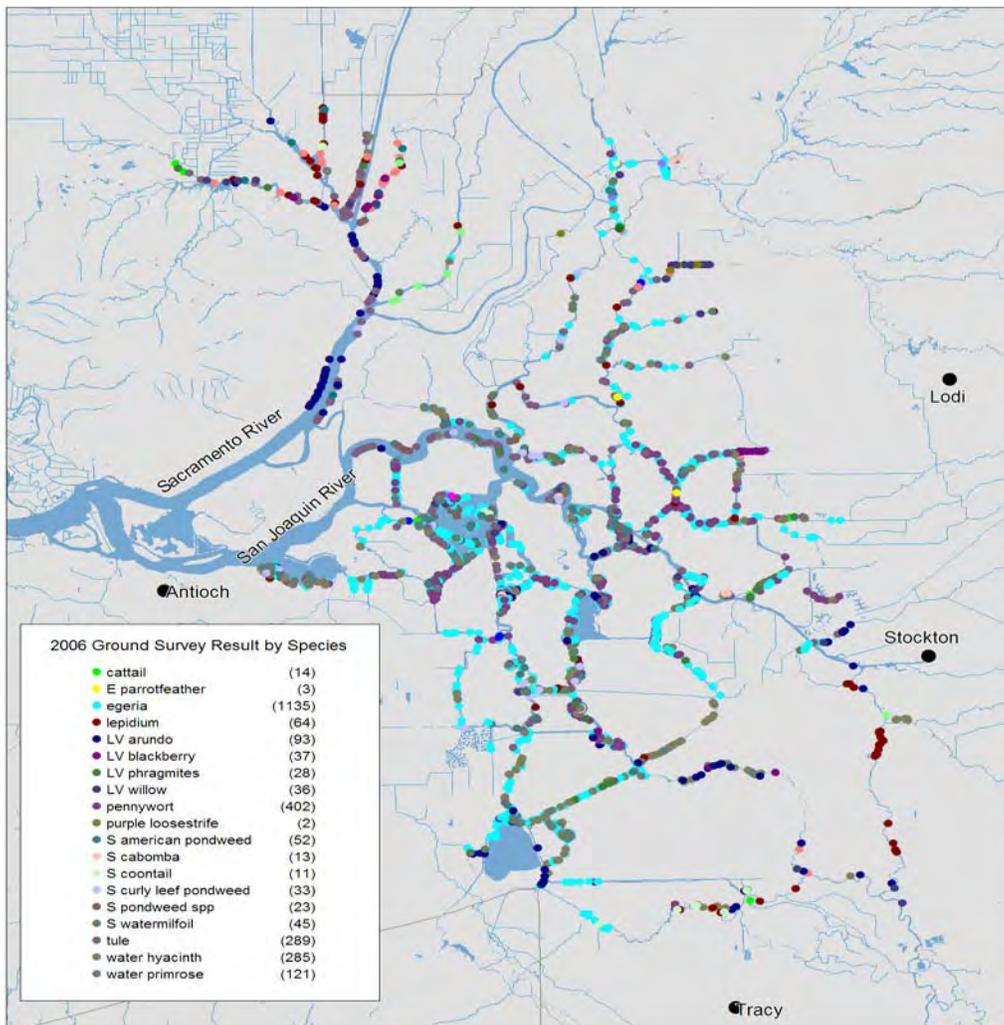
Plate 12. Results of the 2006 Ground Survey to Provide Verification for Aerial Imagery. Results shown for most significant species.

In 2006, the Department again cooperated with the California Department of Boating and Waterways and the Center for Spatial Technologies and Remote Sensing in conducting a remote sensing project to detect, quantify, and map Brazilian waterweed, water hyacinth, and other aquatic weeds in the Delta (Mulitsch et al 2005). The remote sensing method was a hyperspectral sensor imaging system carried by an airplane³⁸. Program crews conducted water-based surveys in support of the aircraft survey for two weeks in early and mid June.³⁹ The water-based surveys consisted of visiting 3,184 sites in the Delta and associated rivers. At each site several parameters were measured including the weeds present (most sites were chosen because they had large solid patches of a weed of interest, though some mixed
