# THE CALIFORNIA DEPARTMENT OF FOOD AND AGRICULTURE HYDRILLA ERADICATION PROGRAM ANNUAL PROGRESS REPORT 2008

## *PROTECTING CALIFORNIA'S WATERWAYS*

Prepared by Patrick Akers, Supervising Scientist,  
with the assistance of Program Staff

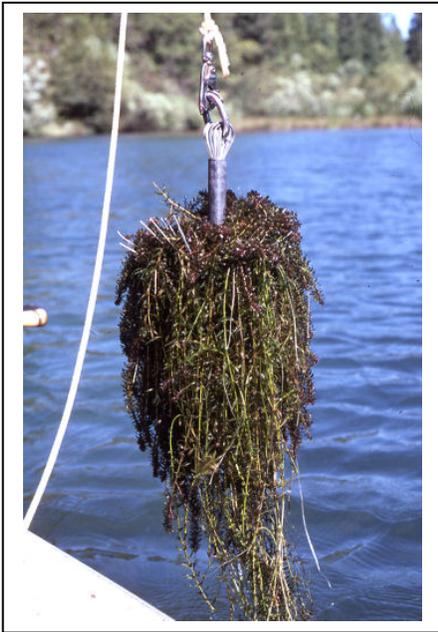
Plate 1. The “hydrilla hook”, a small grappling hook, with hydrilla

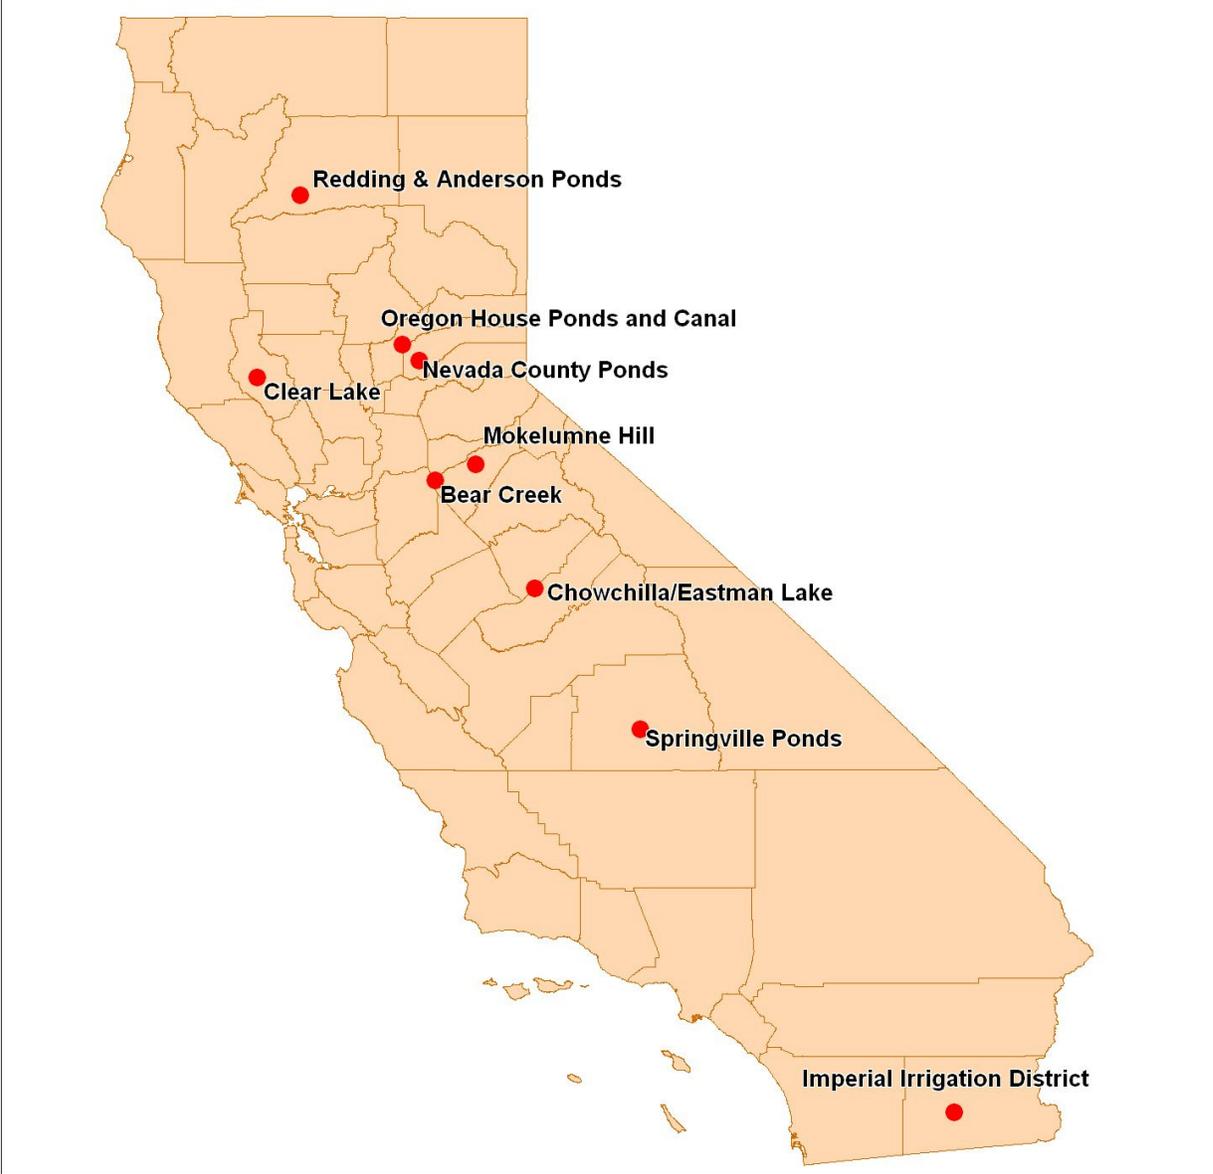
**Plate 2. Current Hydrilla Eradication Projects, 2008**

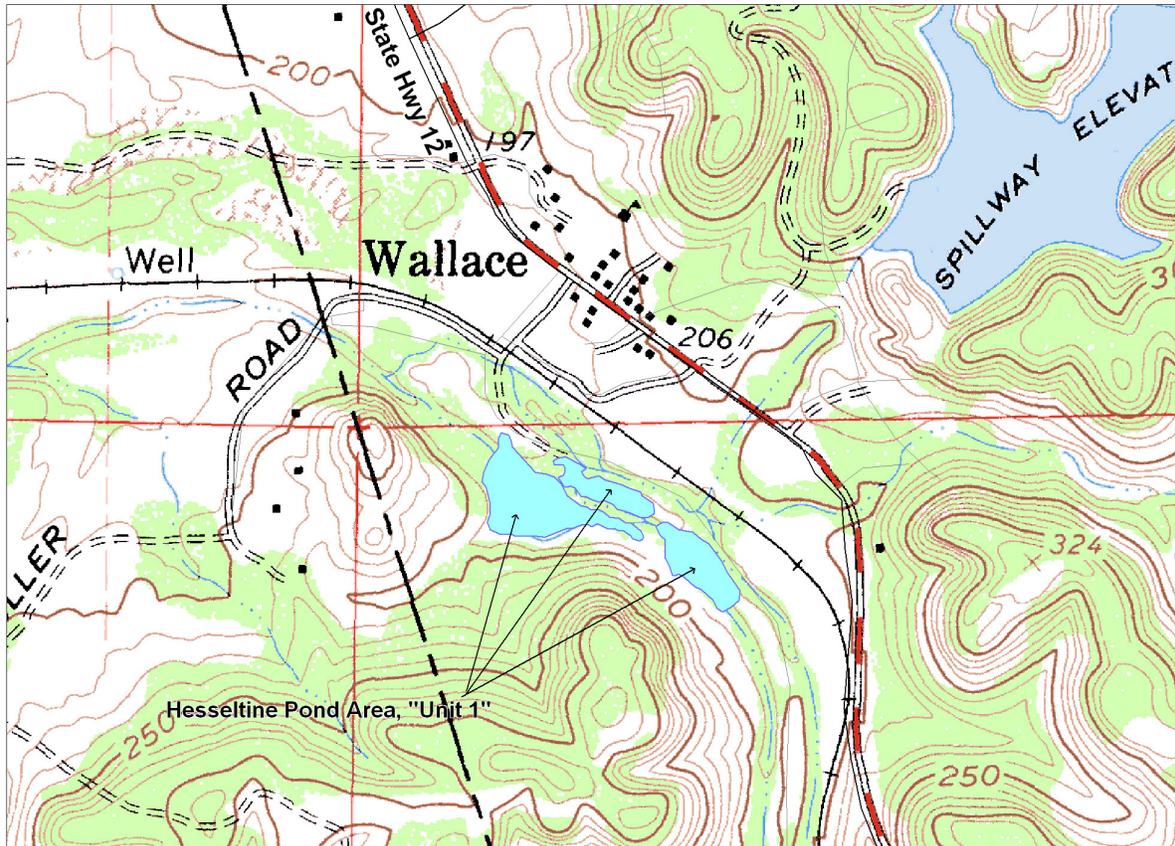
**Plate 3. Active Bear Creek Hydrilla Infestation Area, near Lake Comanche**

The Project is a cooperative effort between the CDFA and the Calaveras County Department of Agriculture. The CDFA convened a Scientific Advisory Panel that made recommendations as to survey, treatment and public education (Stocker, R.K. and L.W.J. Anderson *et. al.* 1988). The Bear Creek infestations are of particular concern because Bear Creek enters the Sacramento-San Joaquin River Delta at Disappointment Slough in San Joaquin County, only about 26 miles downstream from the Hesseltine Pond area (Unit 1), the lowest infested area on the creek.

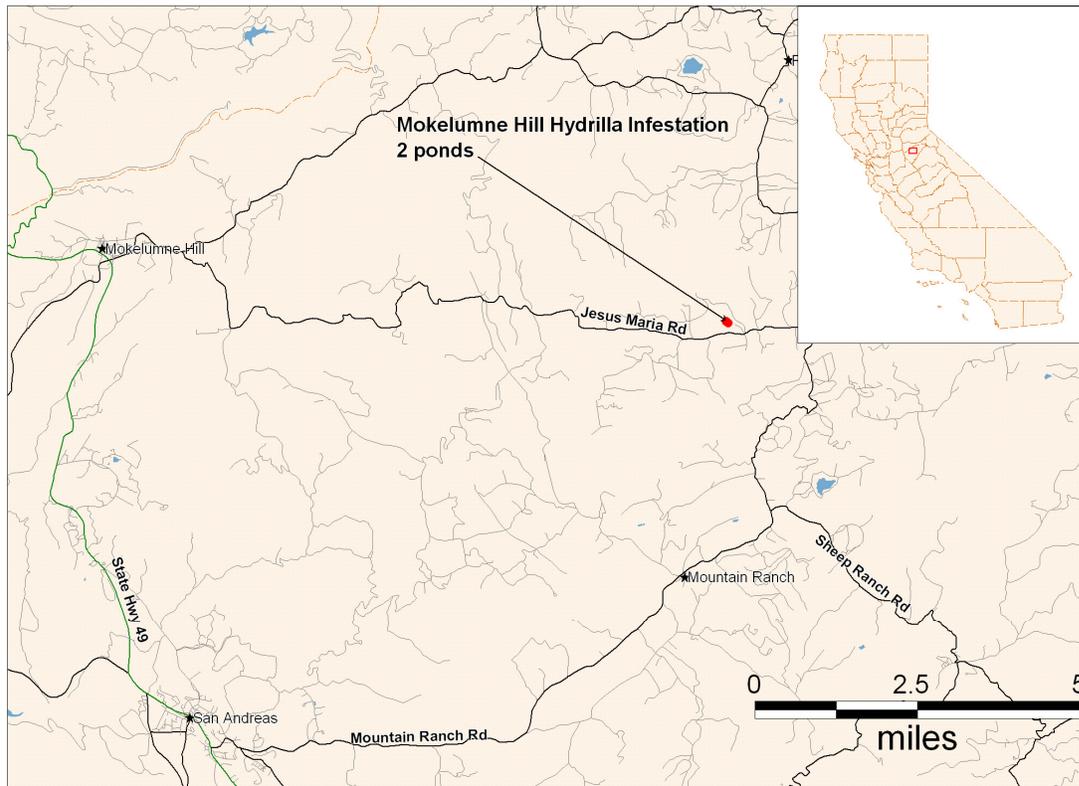
## Plate 4. Mokelumne Hill Infestation Site

Later in 1988, the survey crews discovered a separate infestation in two ponds located near Mokelumne Hill, about 30 miles from the Bear Creek area (Plate 4). The two Mokelumne Hill ponds are 0.45 and 0.15 acres in size and are used for watering cattle. Six other cattle ponds surround them.

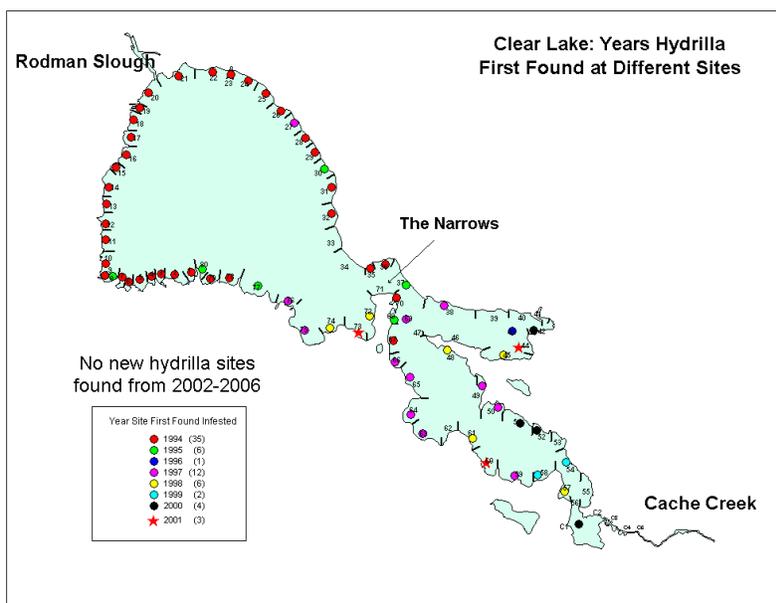
**Plate 5. Map of Clear Lake in Lake County Showing Location of Hydrilla Program Management Units and the Year Hydrilla First Detected in Each Unit.**

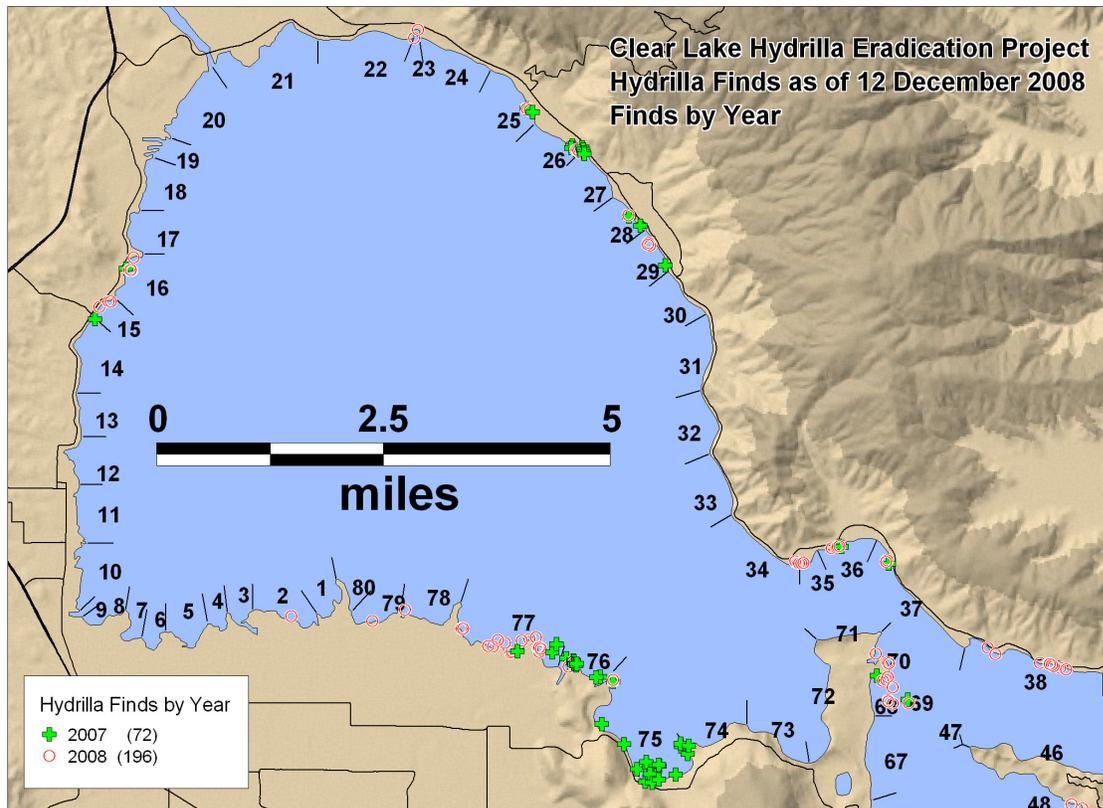
**Plate 6a. Hydrilla Finds in Clear Lake, 2008 Season: Western section of the lake.**

No hydrilla plants were detected in 2004, 2005 or 2006, but they reappeared in 2007 (Table 4). Previously, the last plant found in the lake had been on June 23, 2003. In 2007, about 72 "spots" of hydrilla were found (Plate 6). In 2008, about 196 spots appeared. Most were single

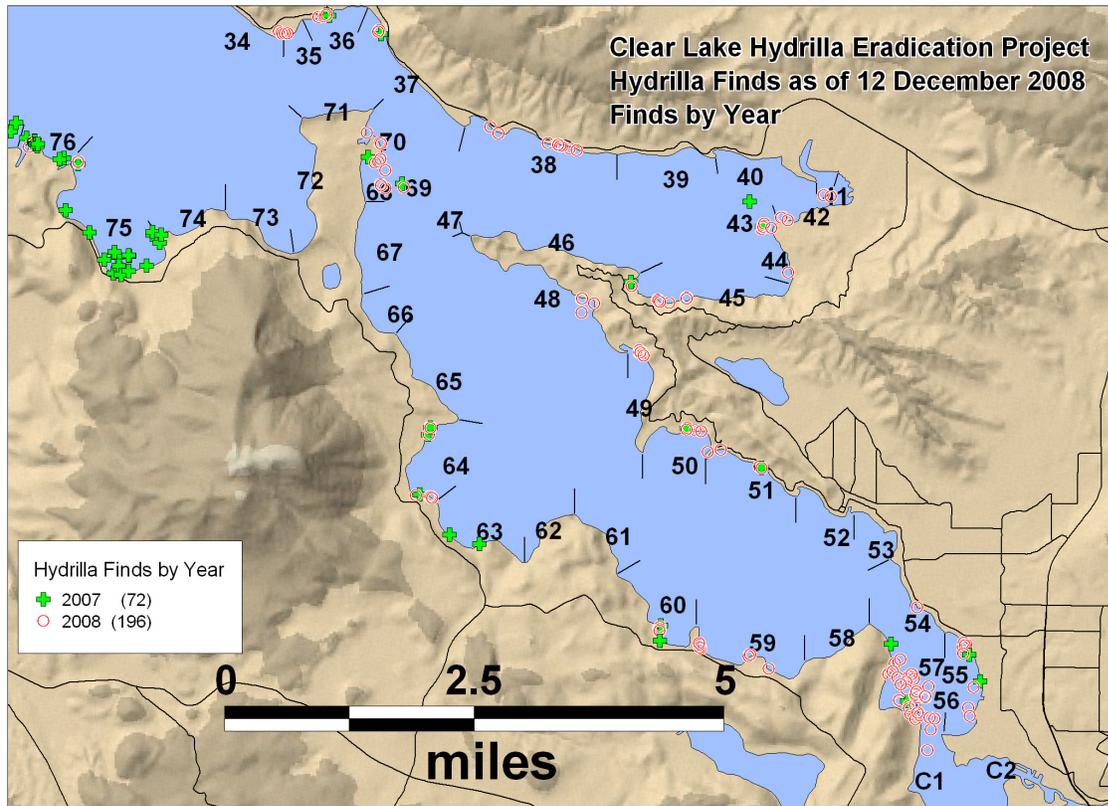
Plate 6b. Hydrilla Finds in Clear Lake, 2008 Season: Eastern section of lake.

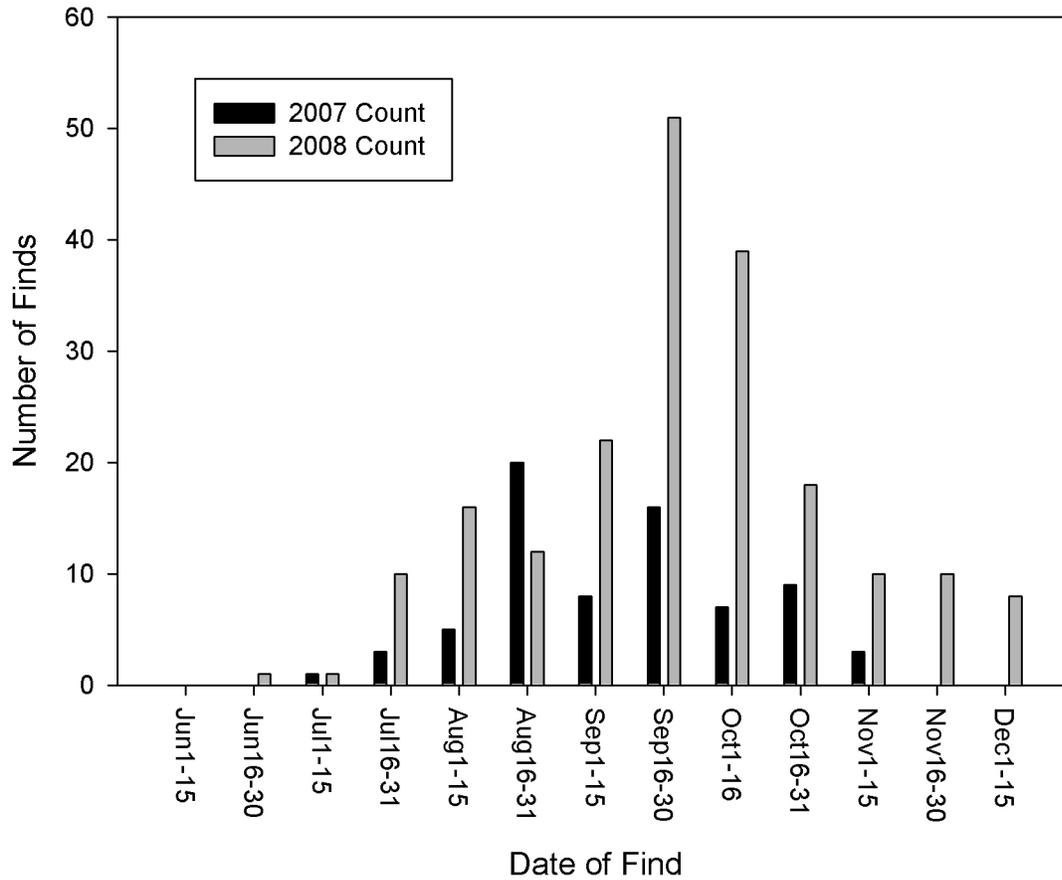
**Plate 7.**

**Clear Lake Hydrilla Project, 2008  
Finds of Hydrilla by Date (per two-weeks)**

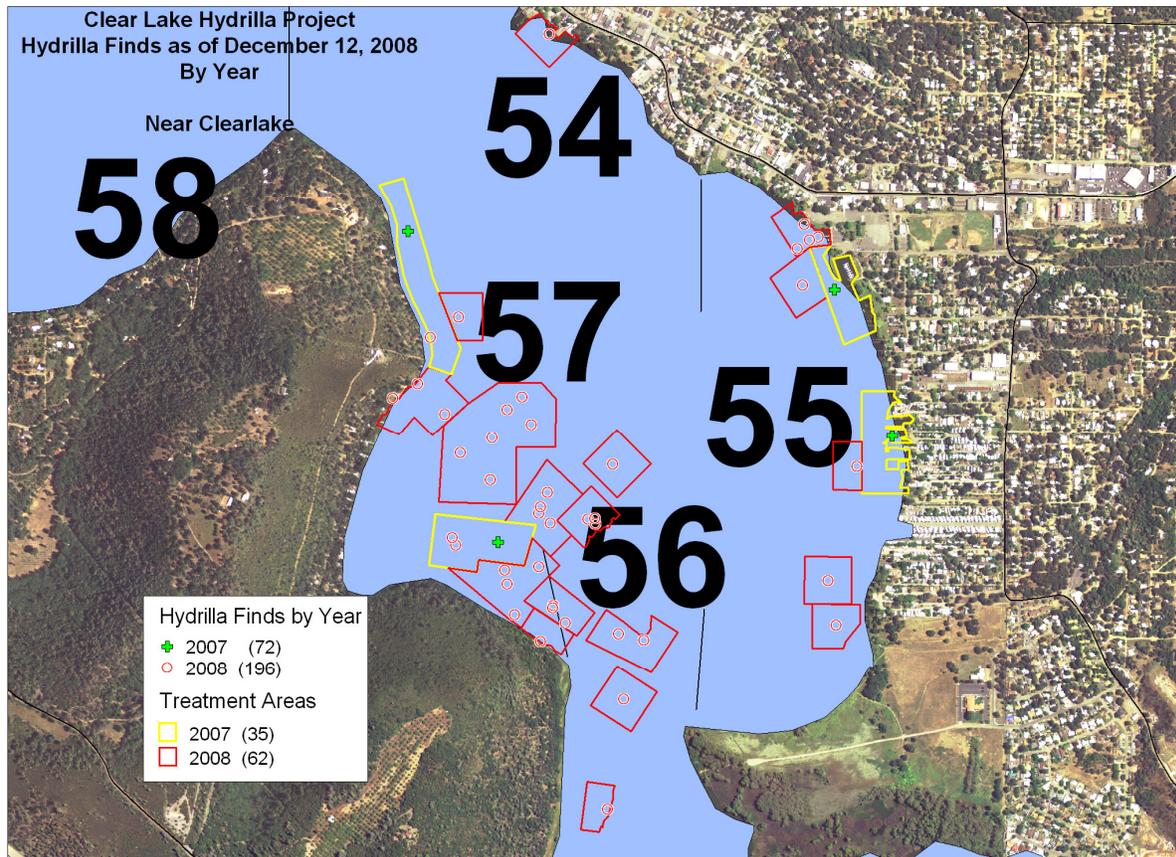
**Plate 8: An example of the increase in the numbers of treatment areas in some locations during 2008. These areas will be consolidated and simplified for the 2009 season.**

The Clear Lake Project's use of fluridone had decreased until 2006 (Table 5) as management units reached the three-year criterion for the end of treatments. That trend also reversed itself in 2007. In 2005, project crews treated 137 acres with fluridone slow-release pellets and none in 2006 (except for a five-acre area to maintain access to a survey area). In 2007, the Project established 248 acres of treatment areas, all of which will require treatment with fluridone for at least three years. During the course of the 2008 season, the 196 new finds this season required creating 62 new treatment areas covering an additional 325 acres. Fluridone use on the established and new acreage totaled 912 pounds of active ingredient. The total treatment area for the beginning of next season will be 573 acres, although that area may change some because Project leaders intend to consolidate and simplify the treatment areas. Many of the new areas are right next to areas created last year (Plate 8).

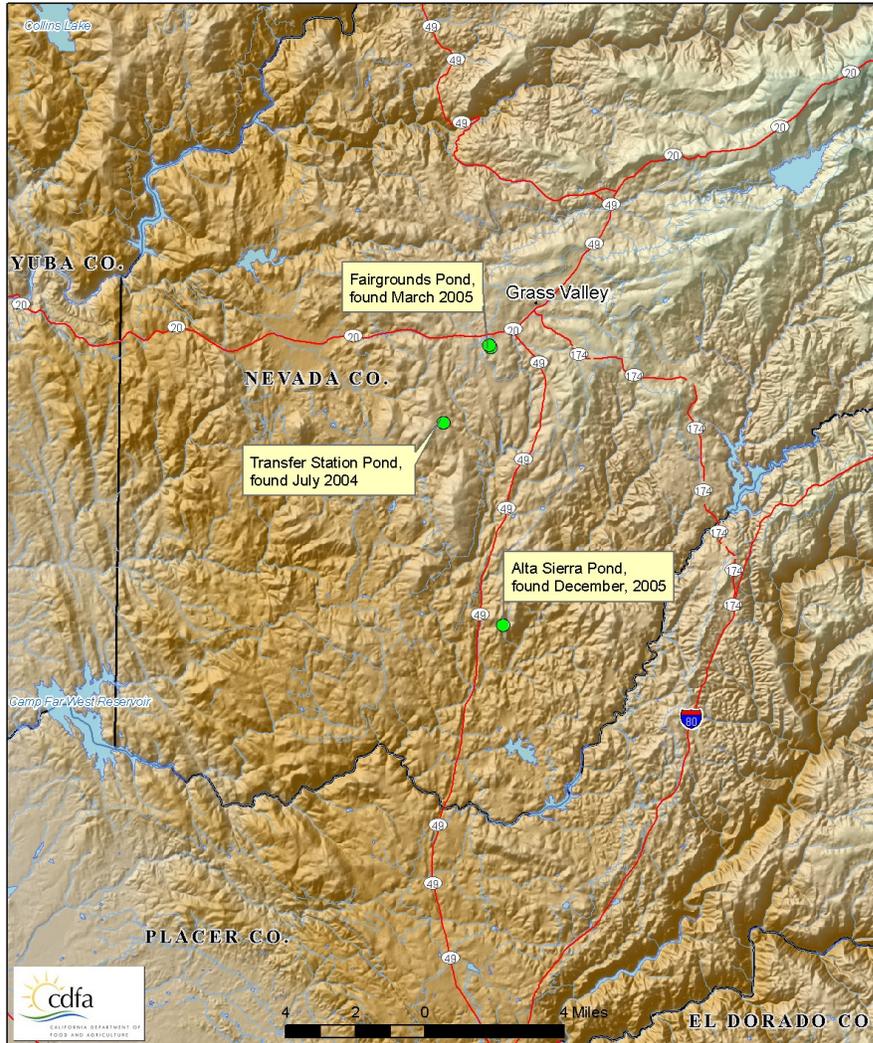
**Plate 9. Map of Hydrilla Infested Ponds currently known to be infested in Nevada County**

**California Department of Food and Agriculture  
Recent Hydrilla Detections in Nevada County, 2005**

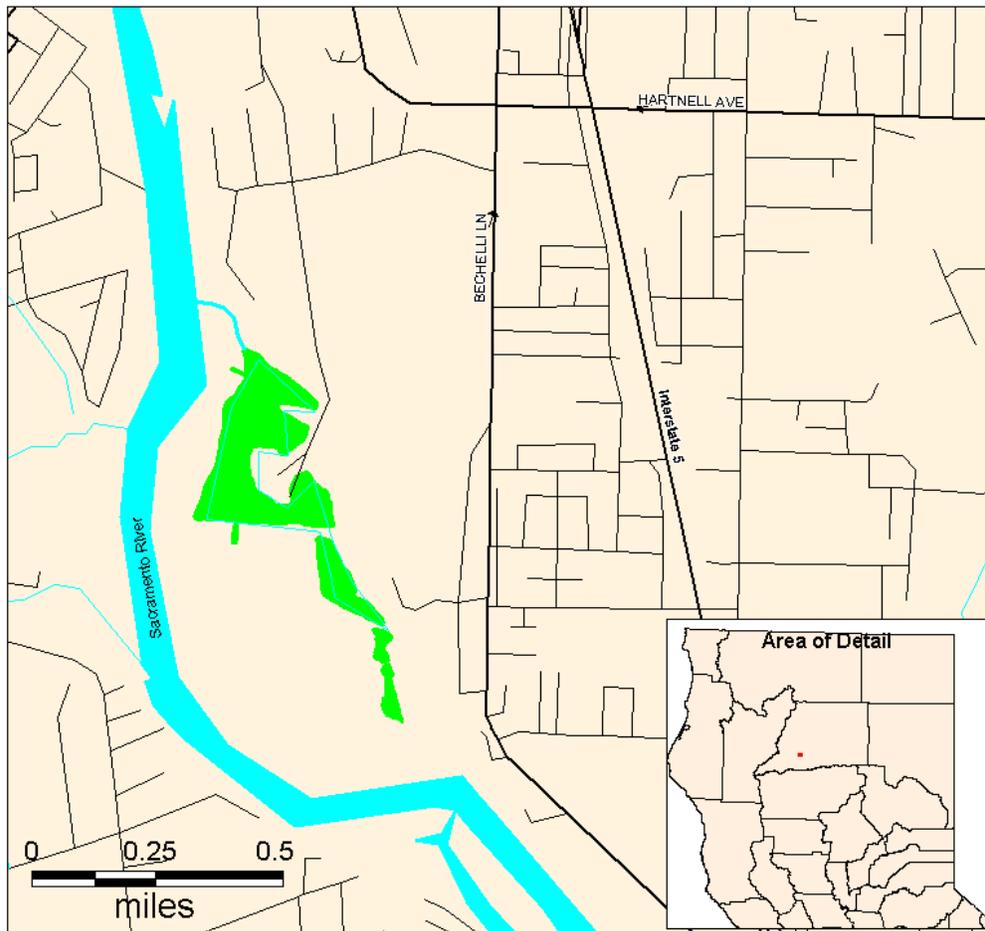
**Plate 10. Map of Infestation at Riverview Golf Course, Redding.**

The Riverview Golf Course infestation consists of four interconnected ponds. The most upstream pond is approximately 30 acres in size and is adjacent to but outside the golf course. Project personnel refer to it as “Rother’s Pond.” It is fed by a small canal from the Sacramento River. The next three ponds are on the golf course, and, heading downstream, are approximately six, two and one acres in area. Water returns to the Sacramento River by a small stream from the one-acre pond. The one-acre pond and return stream often go partially or completely dry in the late summer. When Shasta Project crews first surveyed these ponds in 1996, they found the 30-acre pond to be infested in the lower 15 acres, where the infestation ranged from scattered single plants to small clumps. The six-acre pond was moderately to heavily infested, and the two small ponds were heavily infested.

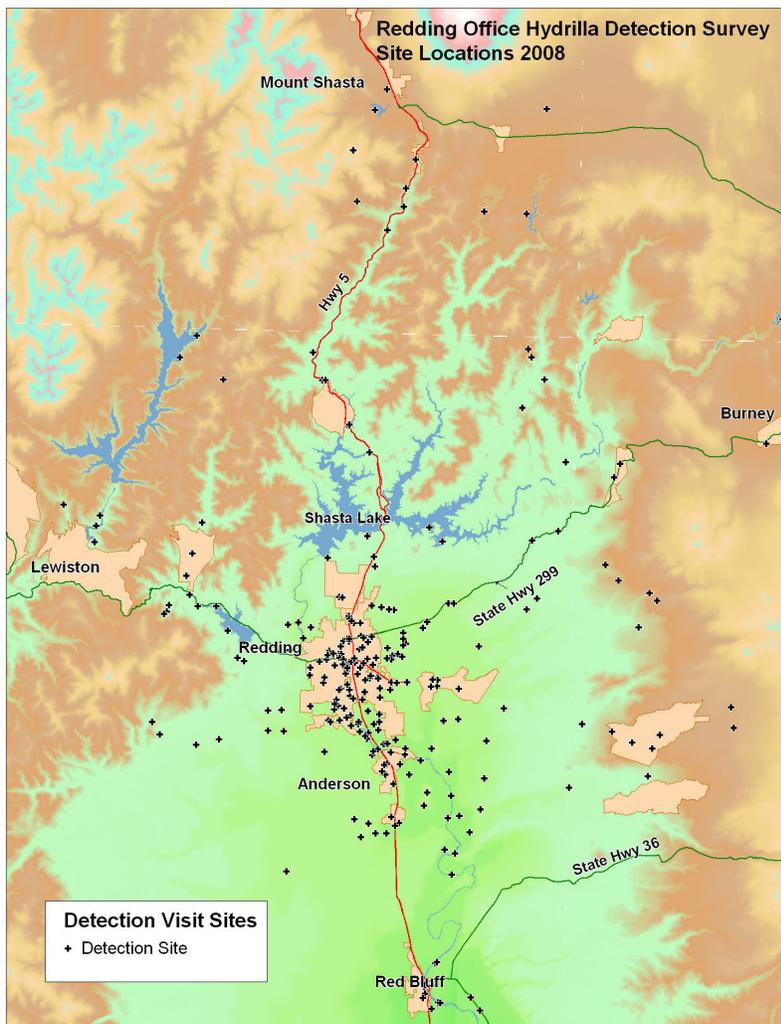
### Plate 11. Water Bodies surveyed by the Shasta Project Crew in 2008

Outside the quarantine zone, Shasta Project personnel surveyed another 226 sites at least once in 2008 (Plate 11). No hydrilla was detected.

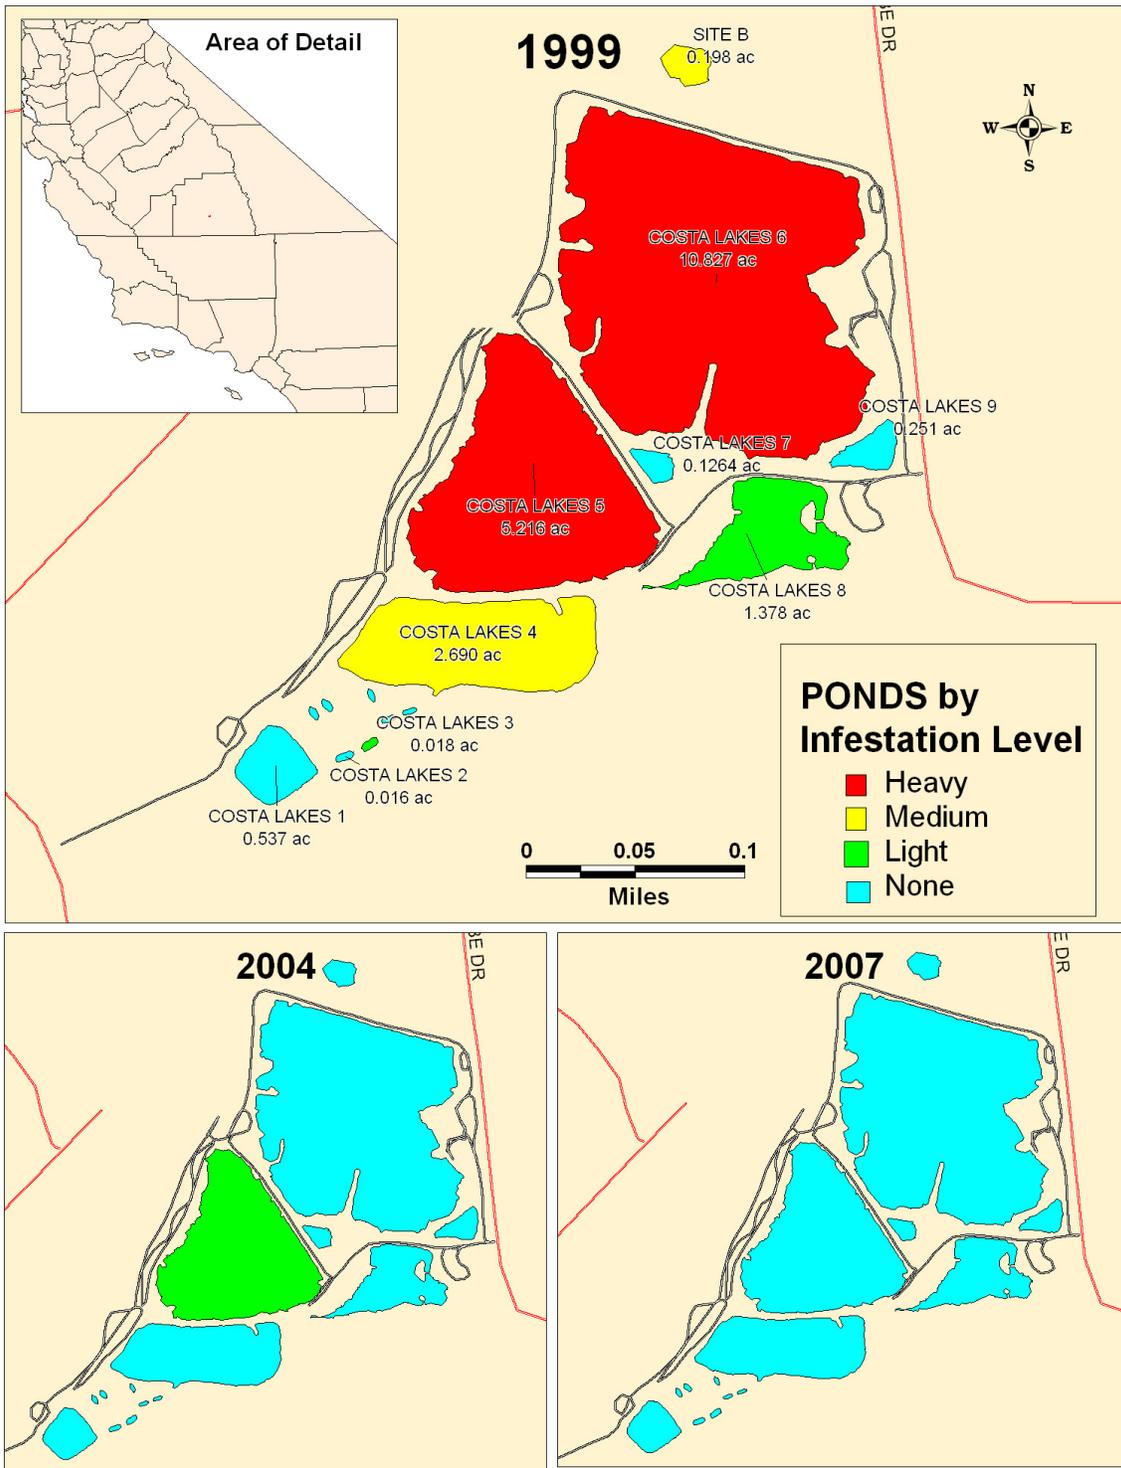
**Plate 12. Map Showing Change in Hydrilla Infestation at the Springville Ponds from the Year of First Detection, 1996, to Current Year, 2008**

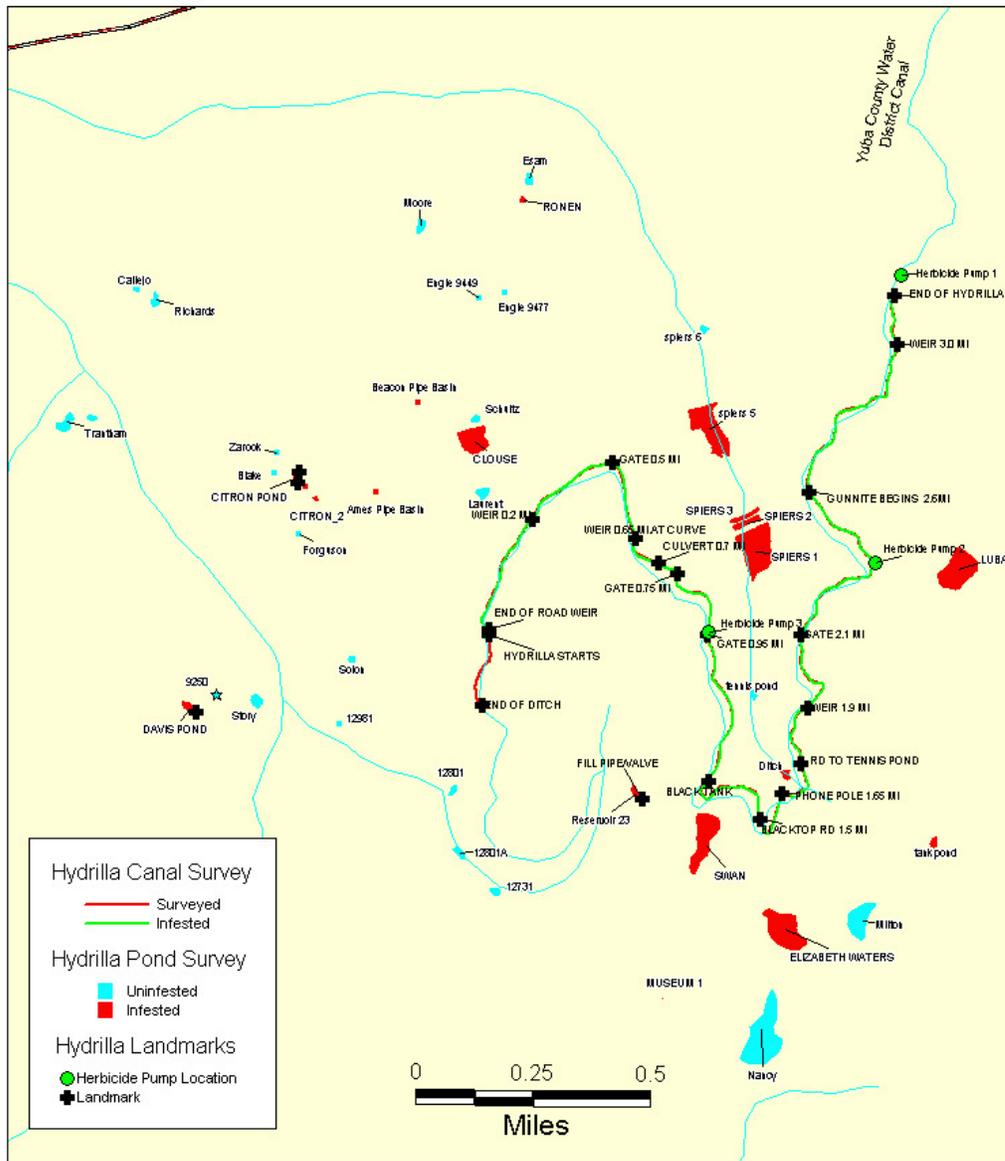
**Plate 13. Hydrilla Infested Ponds near Oregon House, and Hydrilla Infested Portion of Yuba County Water District Canal**

### Oregon House Hydrilla Eradication Project, Yuba County

On August 7, 1997, a third infestation of hydrilla appeared in Yuba County near Oregon House (Plate 13), about halfway between Marysville and Grass Valley off Highway 20. A visitor to a local winery suspected that hydrilla was in one of the ponds on the winery and reported it to the Yuba County Department of Agriculture. Yuba County biologists investigated, found hydrilla and sent a sample to the CDFA Plant Pest Diagnostics Lab for confirmation. Scientists at the United States Department of Agriculture, Agricultural Research Service (USDA-ARS) Exotic and Invasive Weed Unit confirmed it to be the monoecious form of hydrilla.

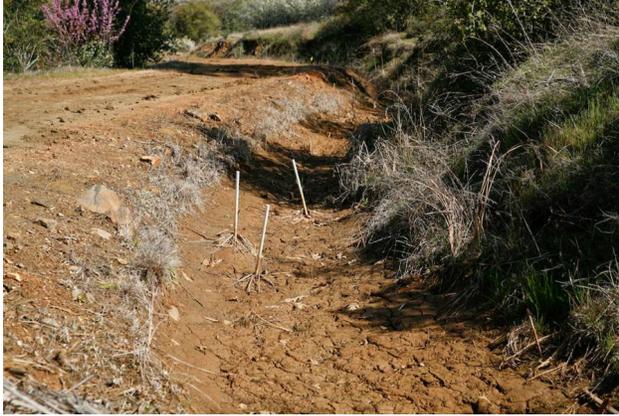
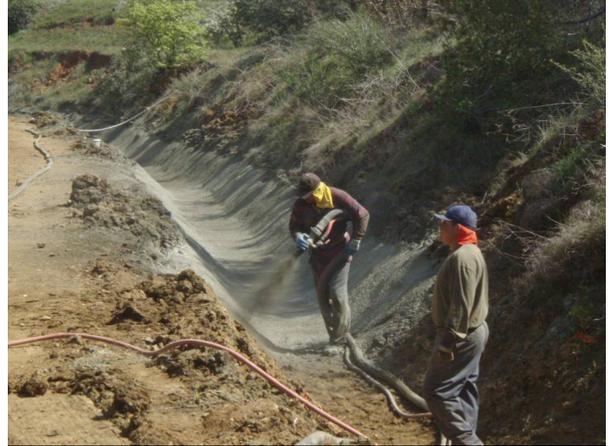
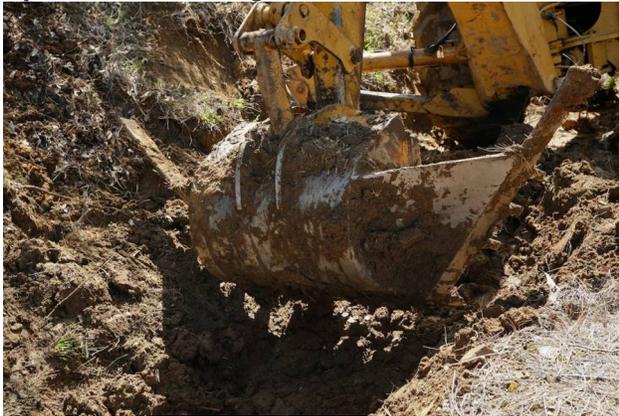
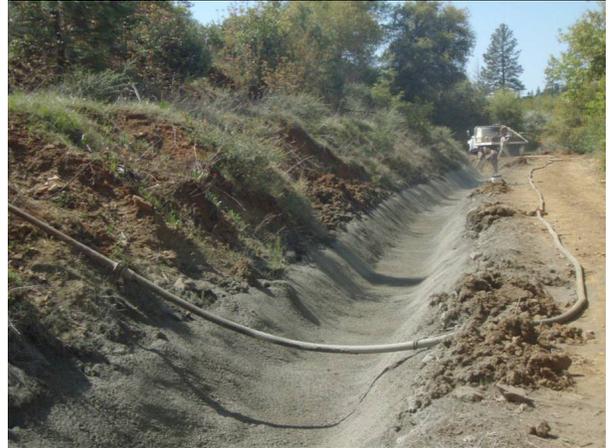
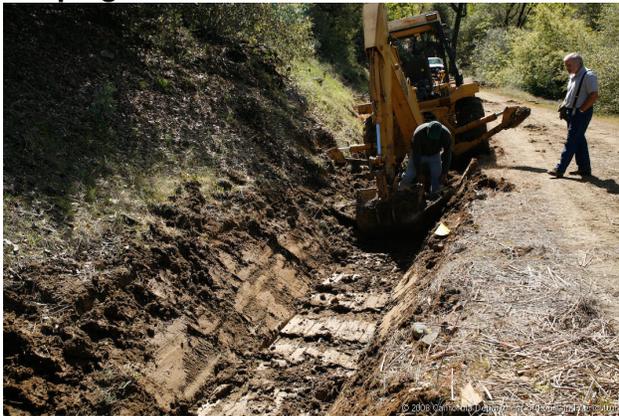
**Plate 14: Concrete lining of the Oregon House canal**

**Before**

**Spraying concrete**

**Special contouring bucket**

**Finished canal – hose comes 150 yards downhill**

**Shaping canal contour**

- 4) The Program lined 3,500 feet of the canal in the Oregon House infestation with concrete. The canal is the epicenter of the infestation, with about three miles infested. Working with a contractor, the Program lined some of the most heavily infested sections. The contractor did excellent work under challenging conditions.
