**CDFFA Hydrilla Program:  
Annual Progress Report  
for 1999 and 2000**

*Protecting California's Waterways*

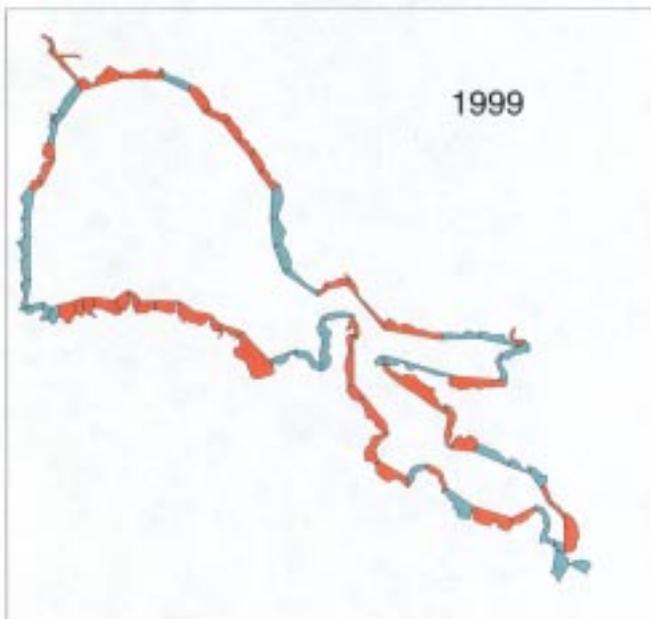
**Map 8:  
Yearly Survey Results, Clear Lake  
Hydrilla Infestation, 1994-2000**

- = Found during Year
- = Surveyed, but None Found

The early surveys each year concentrate on the known infested areas. These areas are all fairly near the shoreline, out to about 500 feet from the shore (Map 8). The first plant for 1999 was found on May 20 in the location designated Area #41, but hydrilla did not begin to appear routinely until the third week of June. The first plant for 2000 was found on June 5 in the location designated Area #49, and hydrilla did not begin to appear routinely until towards the end of June. The initial finds of hydrilla for 1998, 1997, 1996, and 1995, respectively, were on May 18, April 28, May 1, and May 8.

Significantly, after several years of treatment and despite the intensive nature of the surveys, project staff are beginning to find no hydrilla in many areas that once routinely produced plants (Map 8). In 1999, there were 13 areas, all previously infested, where, for the first time, hydrilla could not be found. There were an additional 16 such areas in 2000, although hydrilla was found again in 2000 in three of the 13 areas where it had not been found in 1999. Such reappearances underscore the need to keep heavy pressure on an infestation, given the tenacious qualities of this plant and the difficulties of finding and killing every last individual in the murky waters of Clear Lake. All infested areas have had very low plant densities in 1999 and 2000. In most cases, only plant fragments or a few scattered plants were found in any area, where any hydrilla was found at all. While newly infested areas continue to be found due to the ease of movement of the plant, the overall level of suppression is very high.

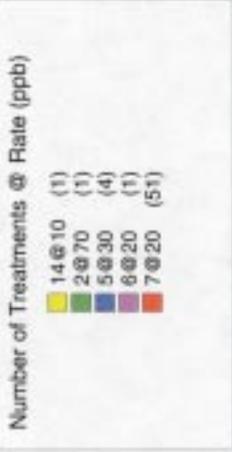
# Map 9: Clear Lake Sonar Treatments in 2000

The applications of Sonar™ later in the season are made to stop production of the vegetative propagules known as tubers and turions. Halting their production is a major requirement for hydrilla eradication. Tuber and turion production in hydrilla is a response to the changing photoperiod. As daylight hours decrease, generally starting around August 1 through 15, the production of vegetative propagules increases significantly. From September through November, plant growth slows down and hydrilla transfers its resources and energy into tubers.

Sonar™ effectively interrupts this process and stops production of propagules. No regrowth occurred in any Sonar™ treated area after the last application.
