**THE CALIFORNIA DEPARTMENT OF FOOD AND AGRICULTURE  
HYDRILLA ERADICATION PROGRAM  
ANNUAL PROGRESS REPORT 2009**

***PROTECTING CALIFORNIA'S WATERWAYS***

Prepared by Patrick Akers, Supervising Scientist,  
with the assistance of Program Staff

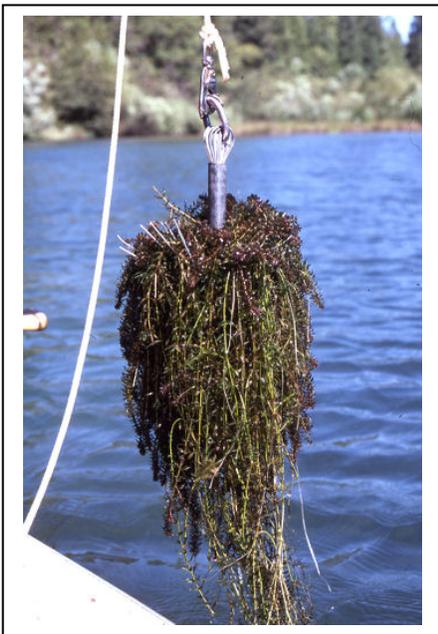
Plate 1. The “hydrilla hook”, a small grappling hook, with hydrilla

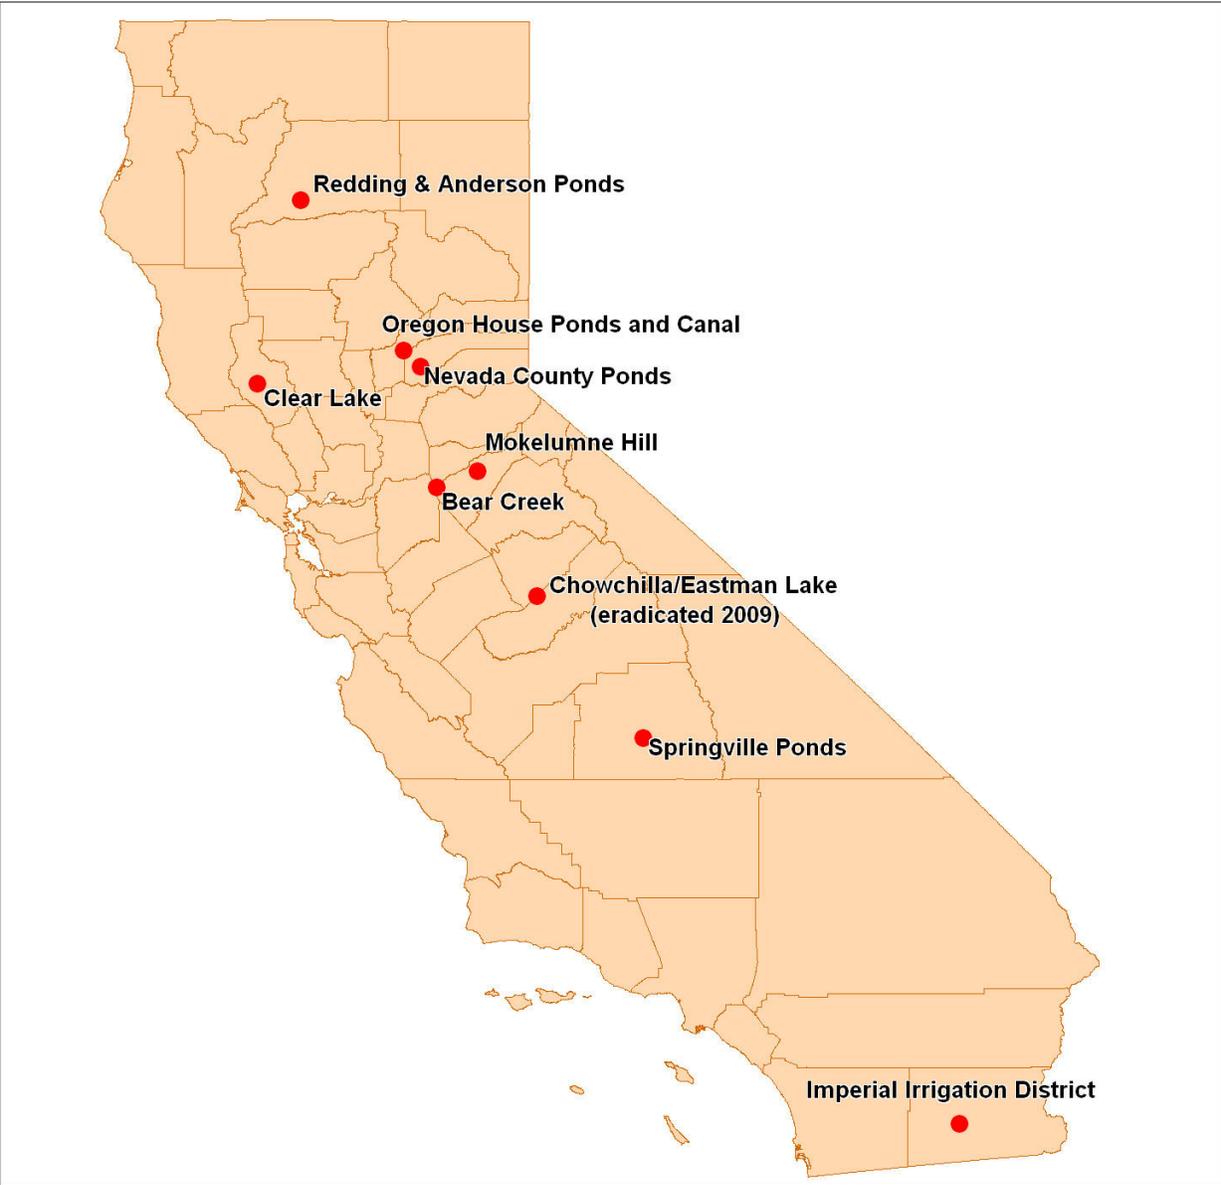
**Plate 2. Current Hydrilla Eradication Projects, 2009**

The status of all current and historical sites in the Hydrilla Eradication Program is summarized in Table 1 and Plate 2.

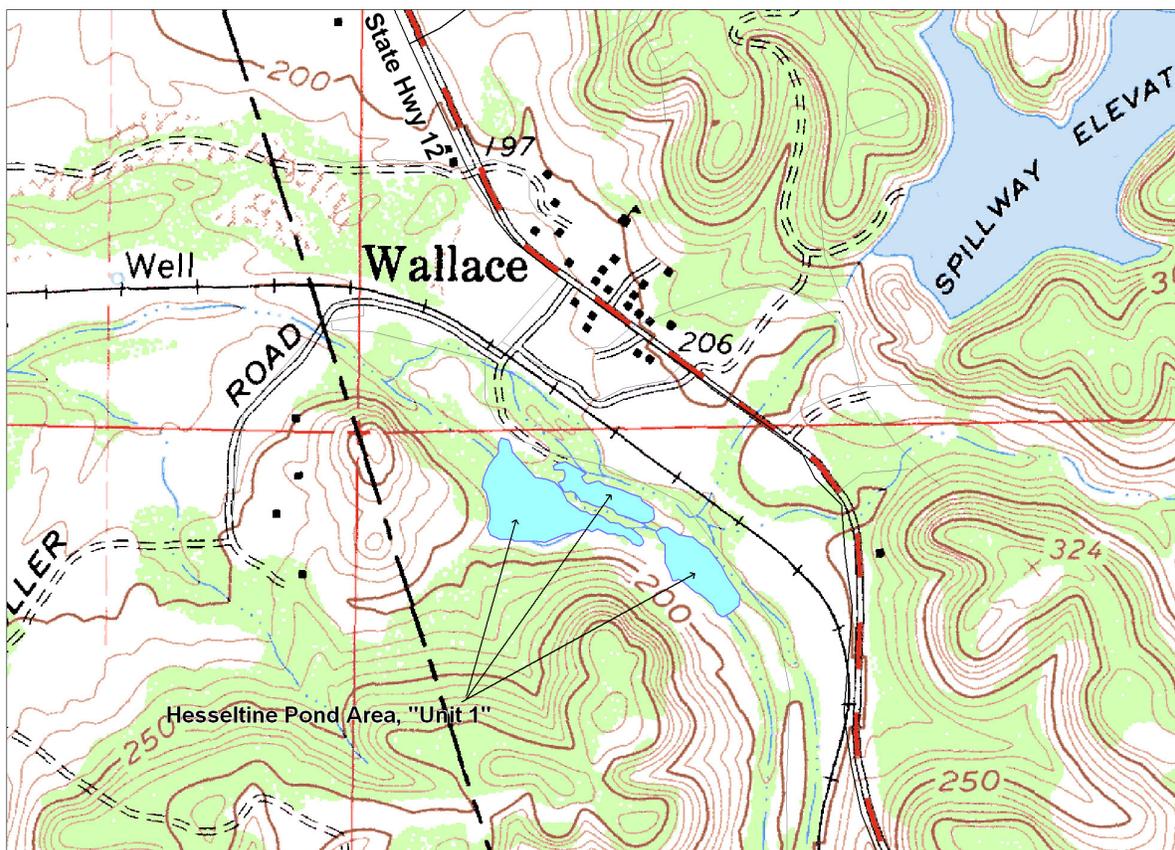
**Plate 3. Active Bear Creek Hydrilla Infestation Area, near Lake Comanche**

The Project is a cooperative effort between the CDFA and the Calaveras County Department of Agriculture. The CDFA convened a Scientific Advisory Panel that made recommendations as to survey, treatment and public education (Stocker, R.K. and L.W.J. Anderson *et. al.* 1988). The Bear Creek infestations are of particular concern because Bear Creek enters the Sacramento-San Joaquin River Delta at Disappointment Slough in San Joaquin County, only about 26 miles downstream from the Hesseltine Pond area (Unit 1), the lowest infested area on the creek.

In contrast to the upstream management units that are approaching eradication, the Hesseltine area (Unit 1) has had recent hydrilla detections. Unit 1 is a series of ponded and swampy areas, totaling approximately 10 acres (Plate 3). The main ponded area (Hesseltine “main pond”) is located about one half mile downstream from Unit 2 and measures approximately 3.6 acres. The pattern of water flow through the area has been changing in the last several years, which caused the expectations for the main pond to also alter a few times. Until about 2005, a large leak in the East Bay Municipal Utility District (EBMUD) aqueduct kept water flowing in Bear Creek from about Perock Pond (Unit 3) down that kept Hesseltine Pond from ever drying up. EBMUD repaired the leak in late 2004, causing the areas in Hesseltine Pond that once had hydrilla to thoroughly dry out in 2005. Program staff accordingly believed that this particular infestation was doomed. However, the property owner blocked the outlet to the pond during the

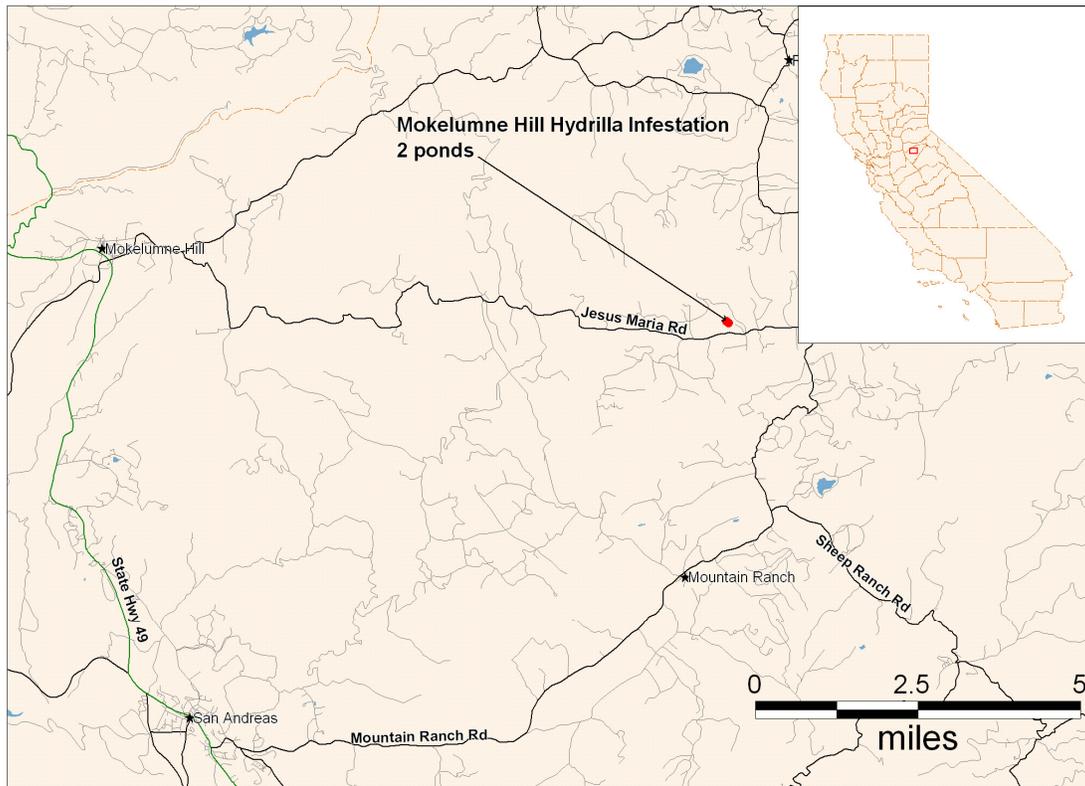
## Plate 4. Mokelumne Hill Infestation Site

Later in 1988, the survey crews discovered a separate infestation in two ponds located near Mokelumne Hill, about 30 miles from the Bear Creek area (Plate 4). The two Mokelumne Hill ponds are 0.45 and 0.15 acres in size and are used for watering cattle. Six other cattle ponds surround them.

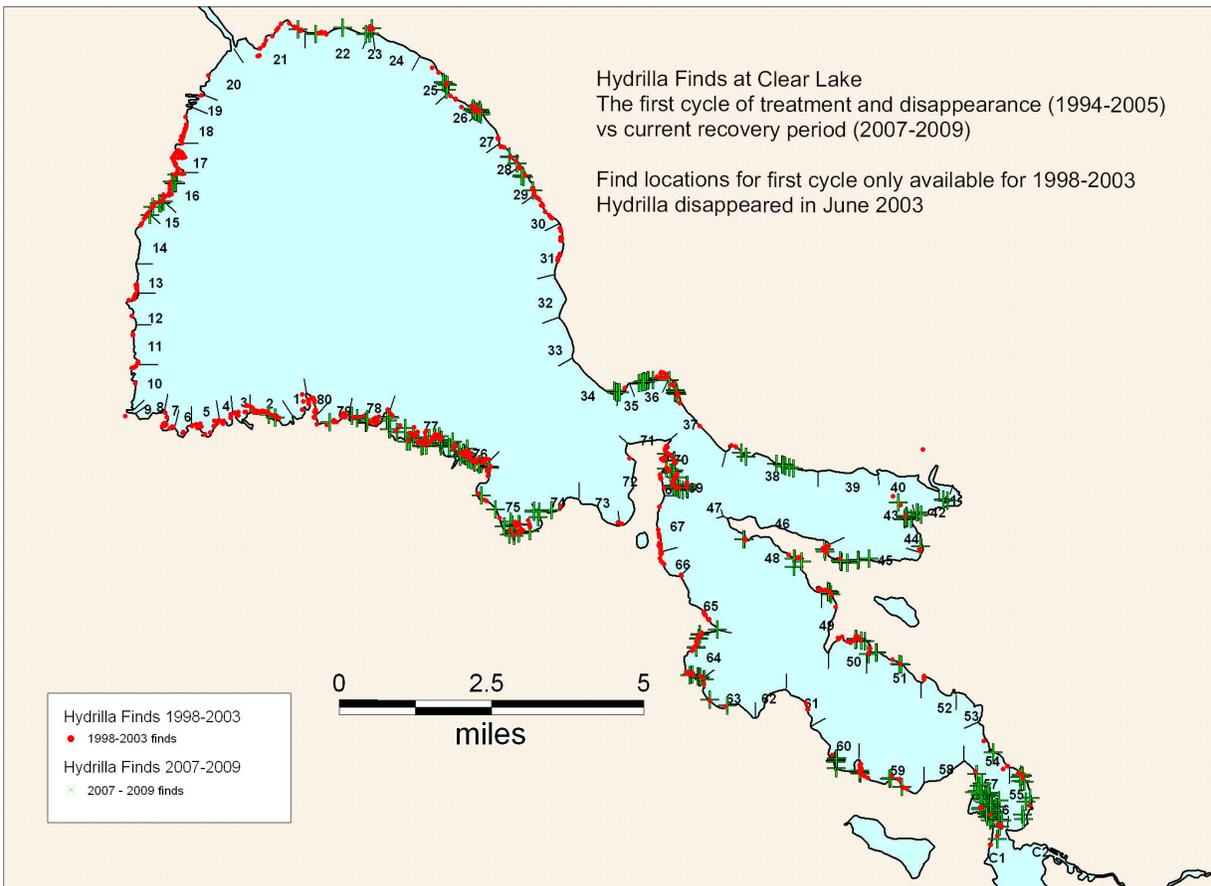
**Plate 5: Plant find locations from 2007-2009 compared to finds in 1996-2003**

The current resurgence of plants clearly comes from tubers that were able to survive the three-year no-plant follow-up treatment. A review of the history of plant finds around the lake through the entire project show that plants that appeared in 2007-2009 largely appeared where plants had been during the first elimination of the plants during 1994 through 2003 (Plate 5). Further, the 2007-09 plants appeared in many parts of the lake all at once; the finds did not concentrate in one or a few locations. This was unlike the pattern of the original infestation, which was concentrated on the western shore of the lake (Plate 6). If the plants had been re-introduced to Clear Lake, it would likely have been at one or a few locations and not in widespread places all at the same time.

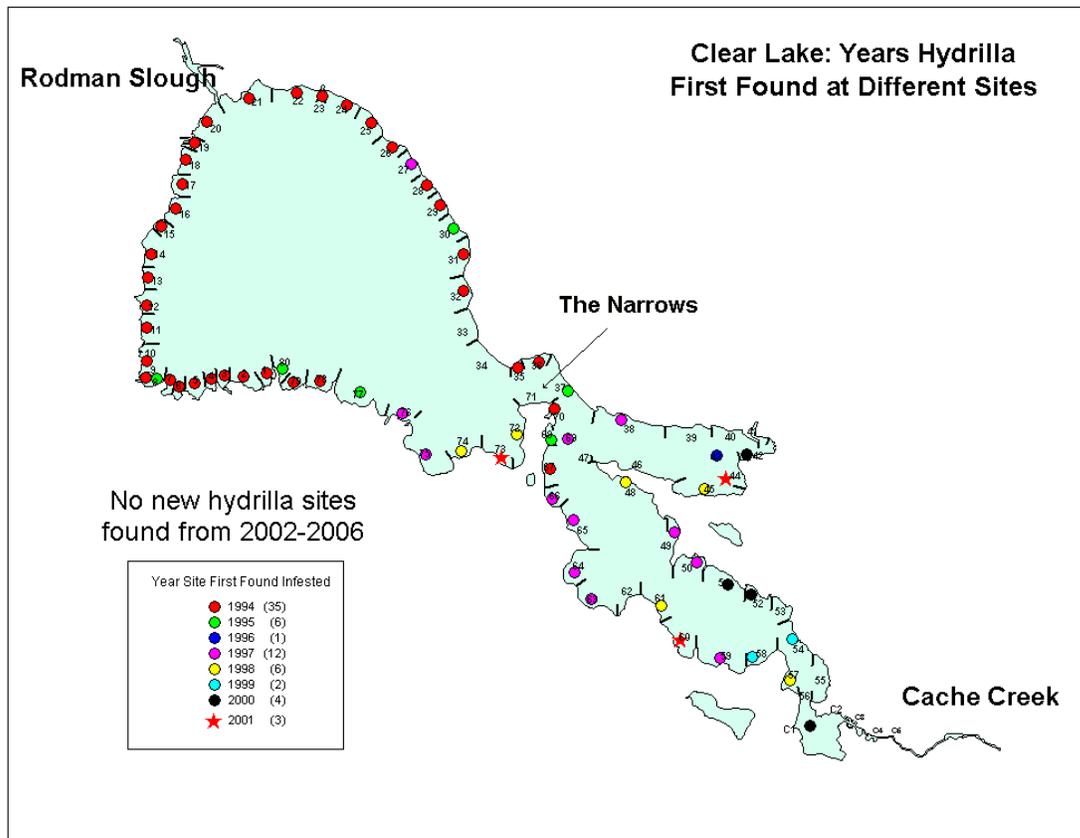
**Plate 6. Map of Clear Lake in Lake County Showing Location of Hydrilla Program Management Units and the Year Hydrilla First Detected in Each Unit.**

No hydrilla plants were detected in 2004, 2005 or 2006, but they reappeared in 2007 (Table 4). Previously, the last plant found in the lake had been on June 23, 2003. In 2007, about 72 "spots" of hydrilla were found (Plate 6). In 2008, about 196 spots appeared. Most were single plants, but many were large clumps up to several yards across and topping out at the water's surface, especially during September and October, 2008. In 2009, the crews found about 76 plant locations. This year the plants were in general much less vigorous than last year. Only a couple plants reached the surface, and none was larger than a yard or two in diameter. Most finds were just a few weak stems. The first plant was found on June 9 (July 9 in 2007 and June 17 in 2008), in Unit 60, in the eastern section of the lake. The last find was on November 12 (November 15 in 2007 and December 9 in 2008) in Unit 69 near the Narrows. The first survey in 2009 was on June 8 and the last on November 23. The water temperature at the time of the first survey was 20 degrees Celsius (68 degrees Fahrenheit) and was 10.6 degrees Celsius (51 degrees Fahrenheit) at the last survey.

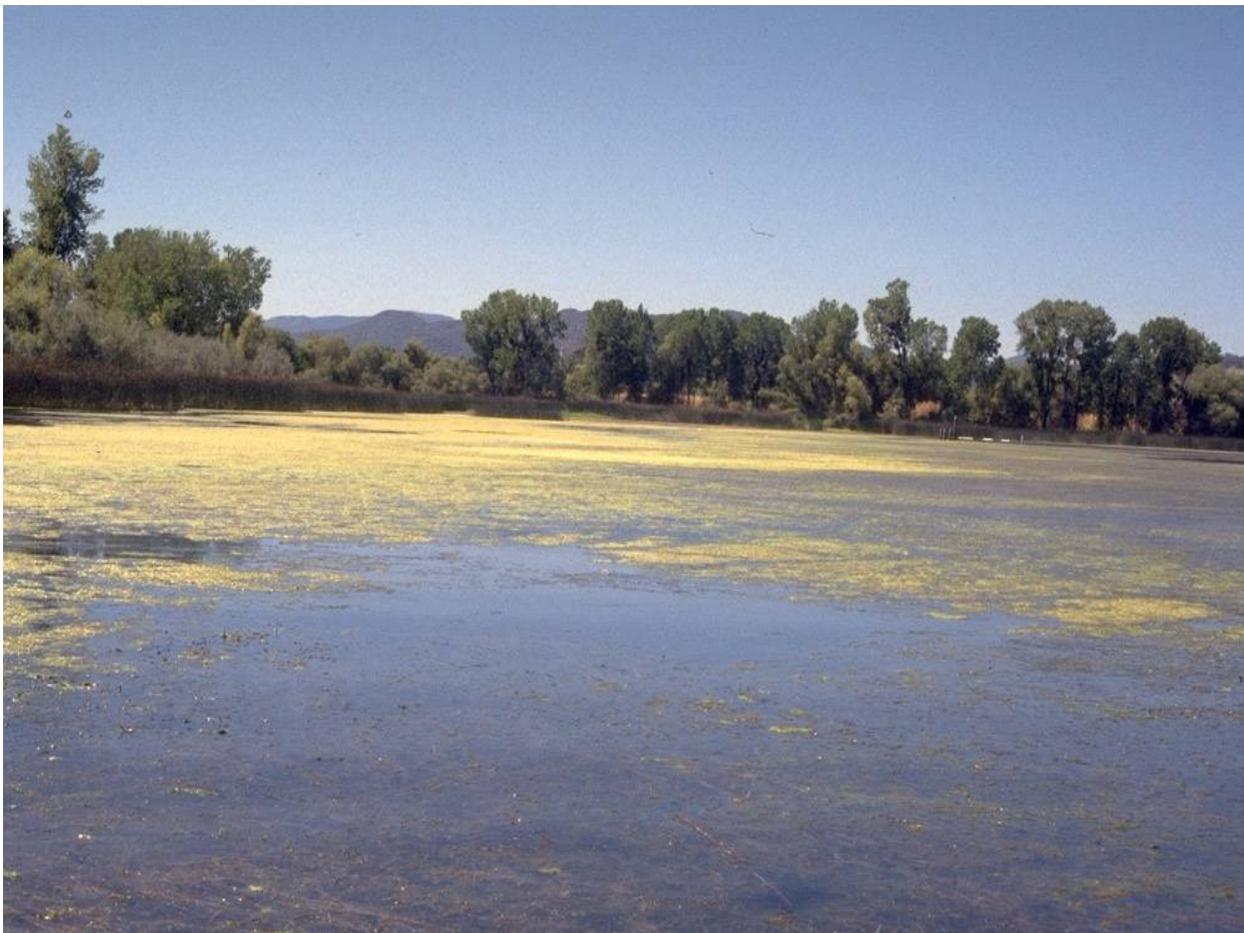
**Plate 7: Hydrilla in Clear Lake, 1994, in the area of Big Valley, before treatments started.**

Hydrilla was first found in Clear Lake on August 1, 1994, during a routine detection survey by personnel from the CDFA and the Lake County Department of Agriculture (Plate 7). The CDFA and Lake County biologists responded rapidly and applied copper herbicide to some infested areas within two weeks of the first detection. In addition, the CDFA, with the cooperation of the Lake County Agricultural Commissioner, put Lake County under quarantine<sup>22</sup>. The CDFA and Lake County biologists conducted the initial delimiting survey in 1994 and found that 175 to 200 surface acres along the shoreline of the upper arm of Clear Lake were infested (Plates 6, 7). Infestation levels varied from a few scattered plants to dense populations covering many acres. In addition, in both 1994 and 1995, thousands of hydrilla fragments were visible at some of the boat ramps at the western end of the lake. The CDFA convened a Scientific Advisory Panel in 1994 (Stocker, R.K. and L.W.J. Anderson *et. al.* 1994), which recommended a survey, treatment and public education program.

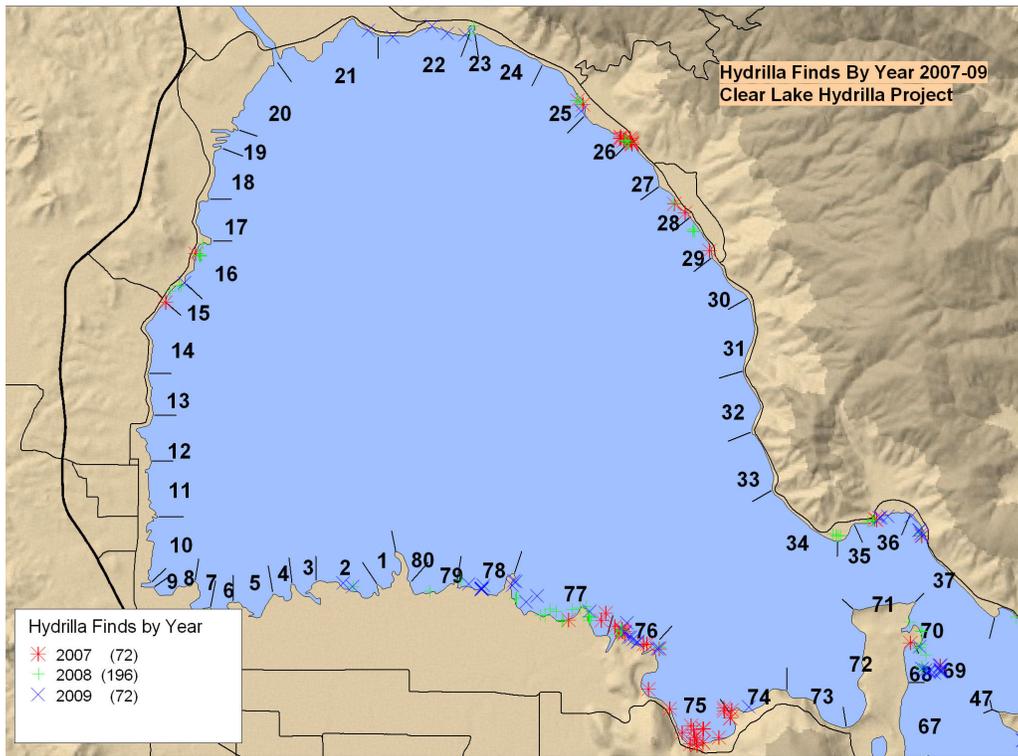
**Plate 8a. Hydrilla Finds in Clear Lake, 2007 - 2009: Western section of the lake.**

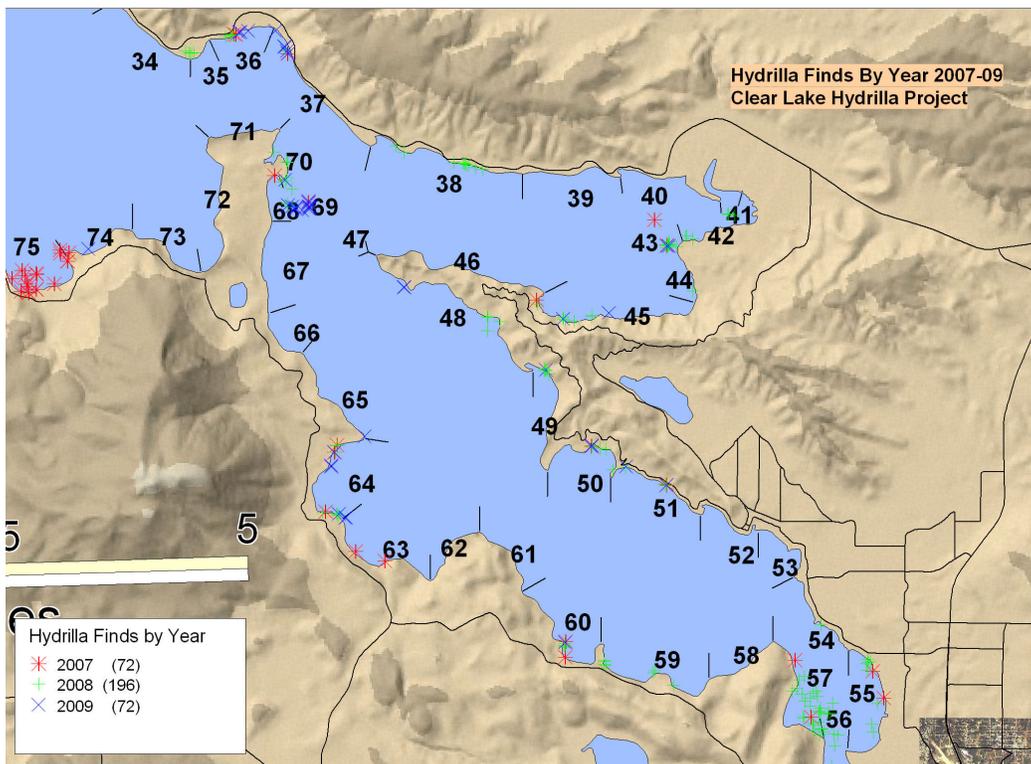
**Plate 8b. Hydrilla Finds in Clear Lake, 2007 - 2009: Eastern section of lake.**

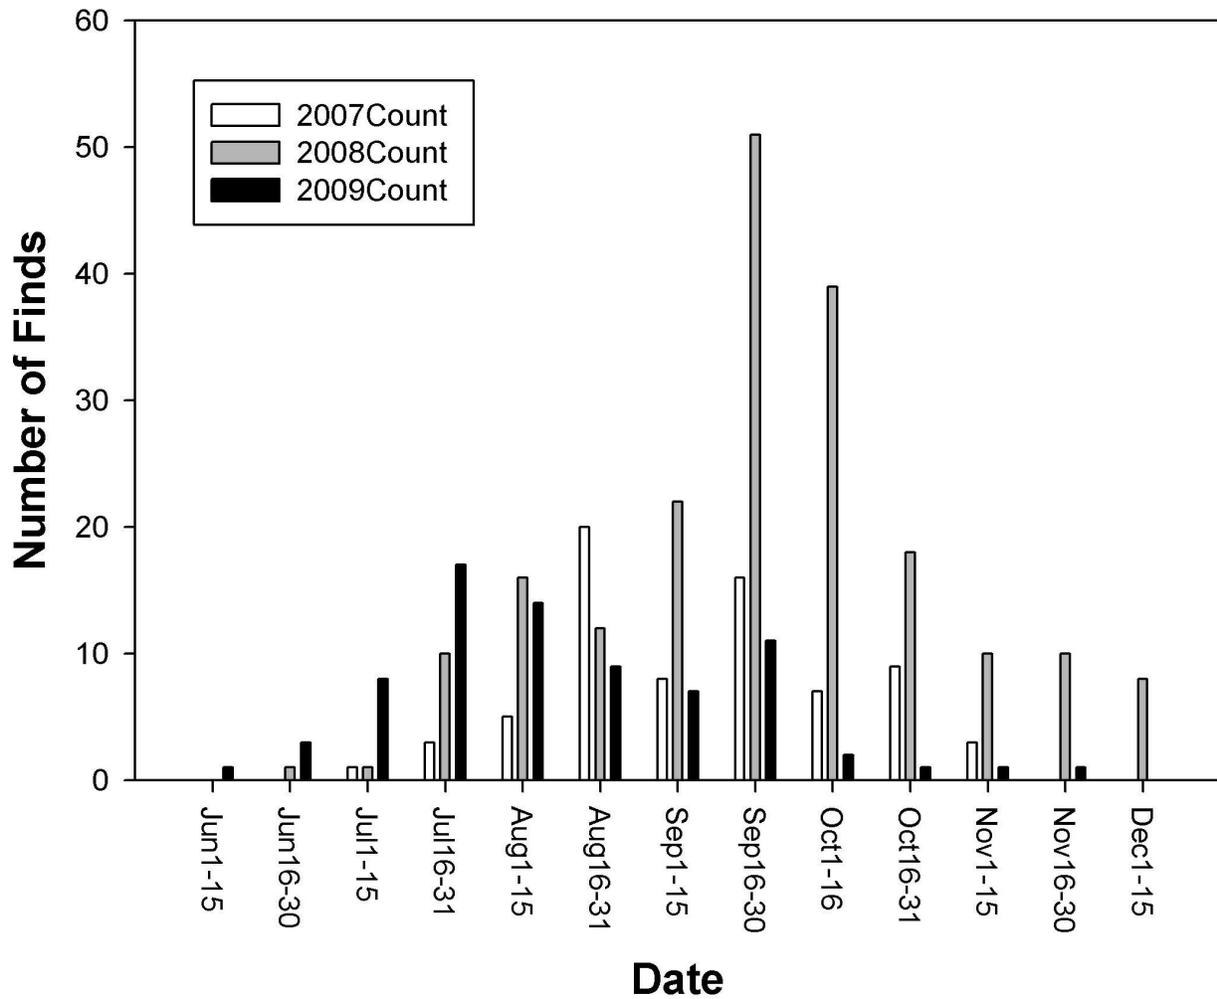
Plate 9.

Clear Lake Hydrilla Project, 2007-09  
 Finds of Hydrilla by Date (counts over two weeks)

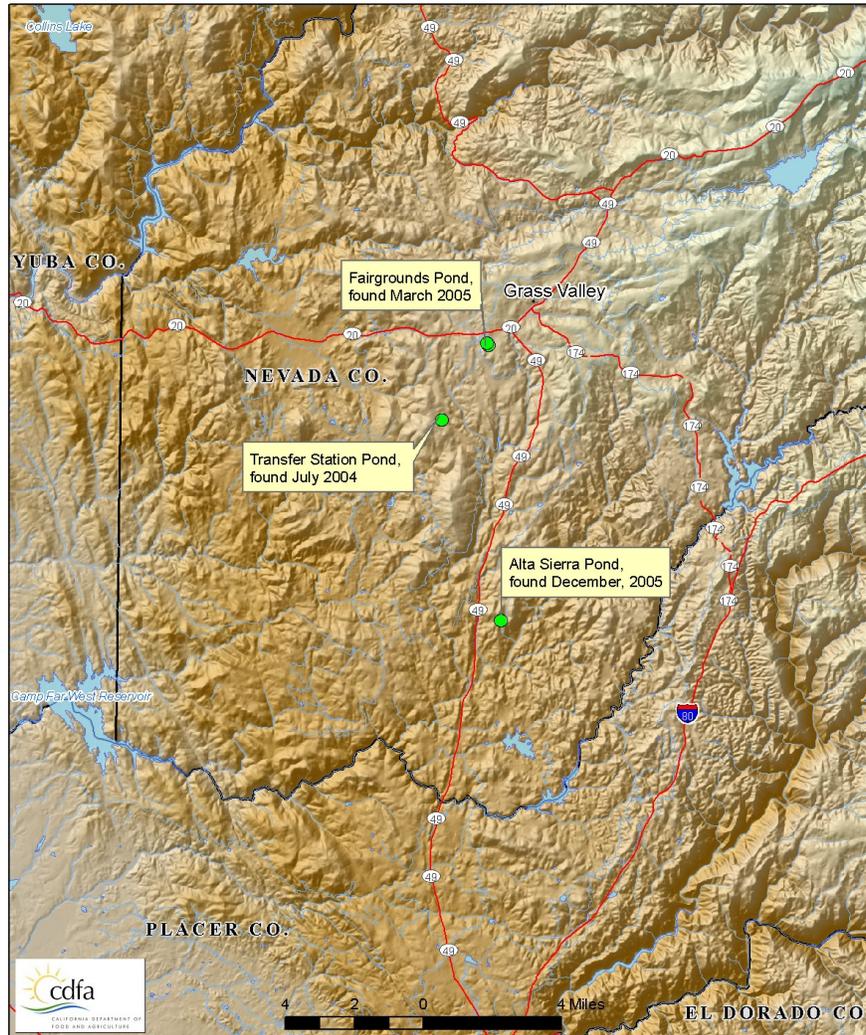
**Plate 10. Map of Ponds currently known to be infested in Nevada County**

**California Department of Food and Agriculture  
Recent Hydrilla Detections in Nevada County, 2005**

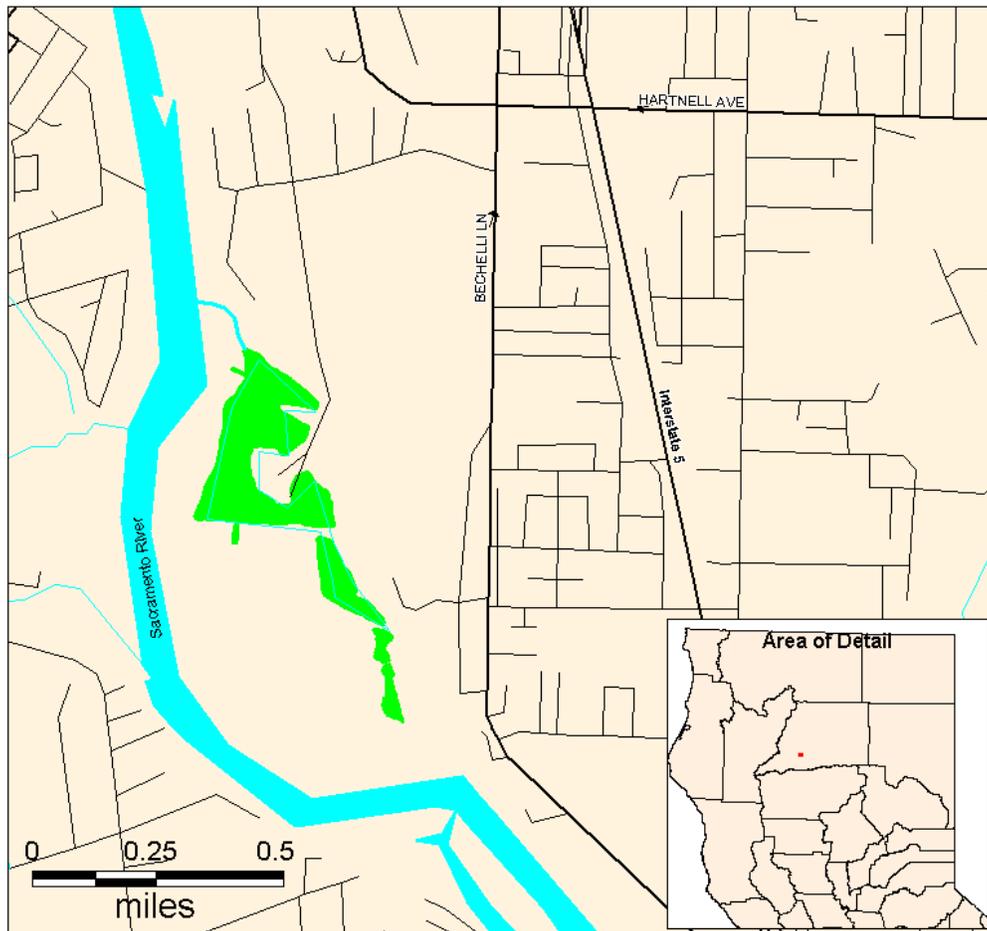
**Plate 11. Map of Infestation at Riverview Golf Course, Redding.**

The Riverview Golf Course infestation consists of four interconnected ponds. The pond farthest upstream is approximately 30 acres in size and is adjacent to but outside the golf course. Project personnel refer to it as “Rother’s Pond.” It is fed by a small canal from the Sacramento River. The next three ponds are on the golf course, and, heading downstream, are approximately six, two and one acres in area. Water returns to the Sacramento River by a small stream from the one-acre pond. The one-acre pond and return stream often go partially or completely dry in the late summer. When Shasta Project crews first surveyed these ponds in 1996, they found the 30-acre pond to be infested in the lower 15 acres, where the infestation ranged from scattered single plants to small clumps. The six-acre pond was moderately to heavily infested, and the two small ponds were heavily infested.

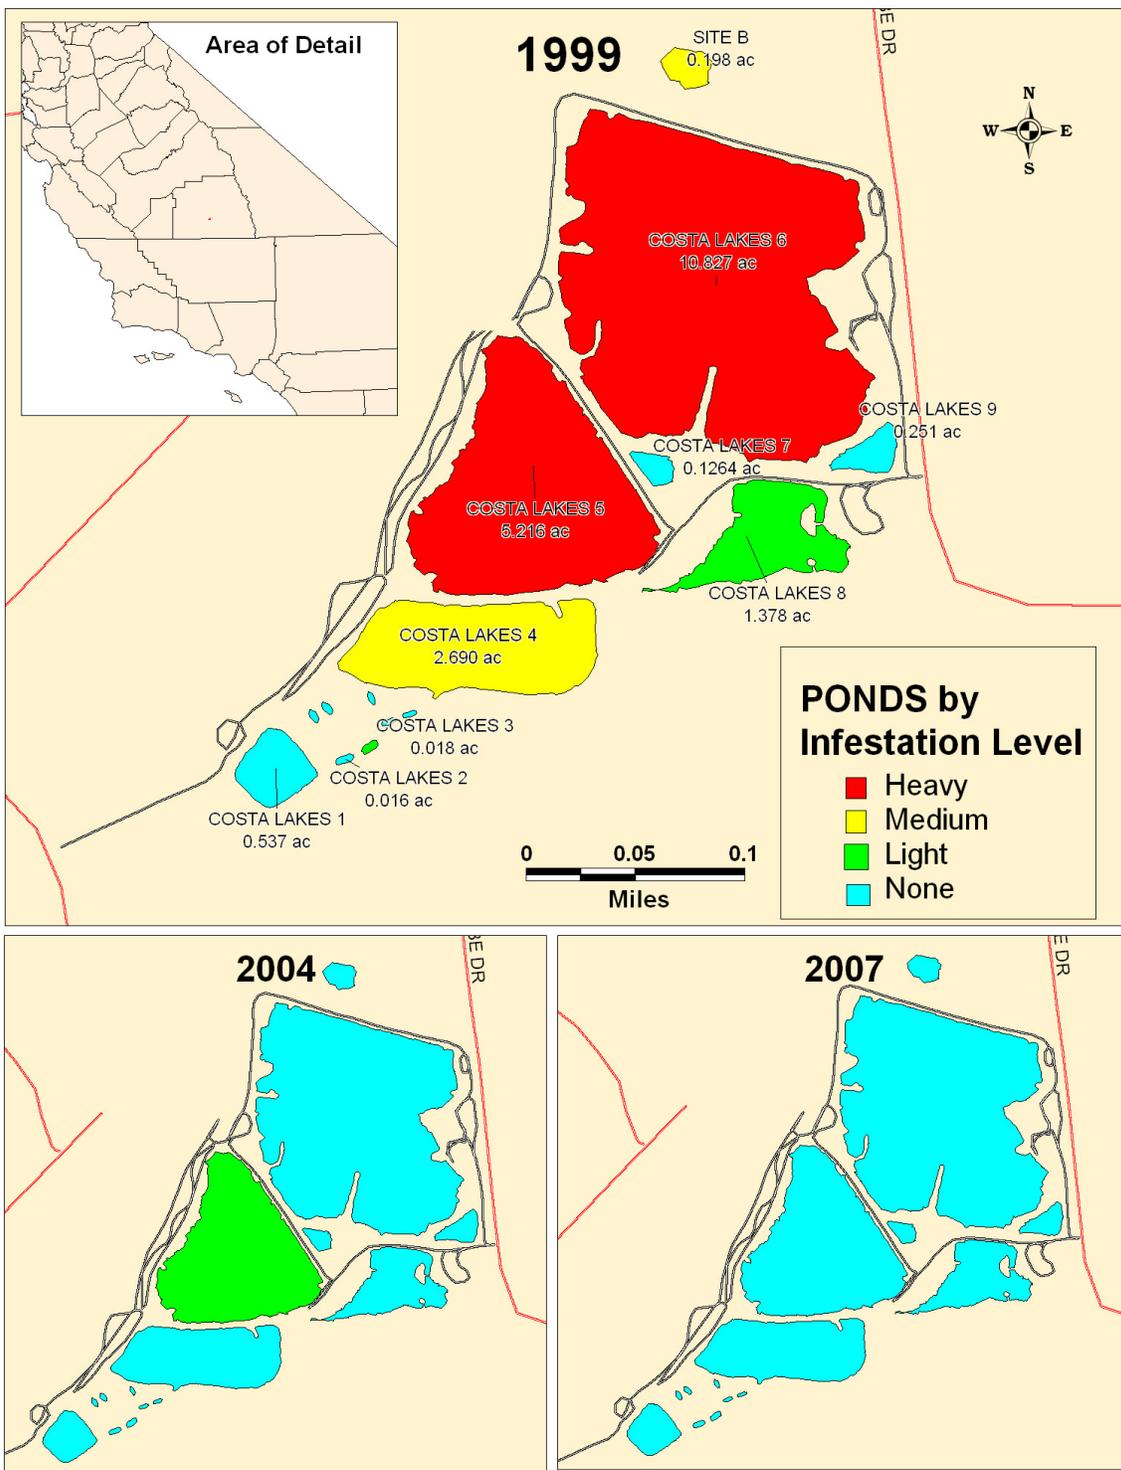
**Plate 12. Map Showing Change in Hydrilla Infestation at the Springville Ponds from the Year of First Detection, 1996, to Current Year, 2009**

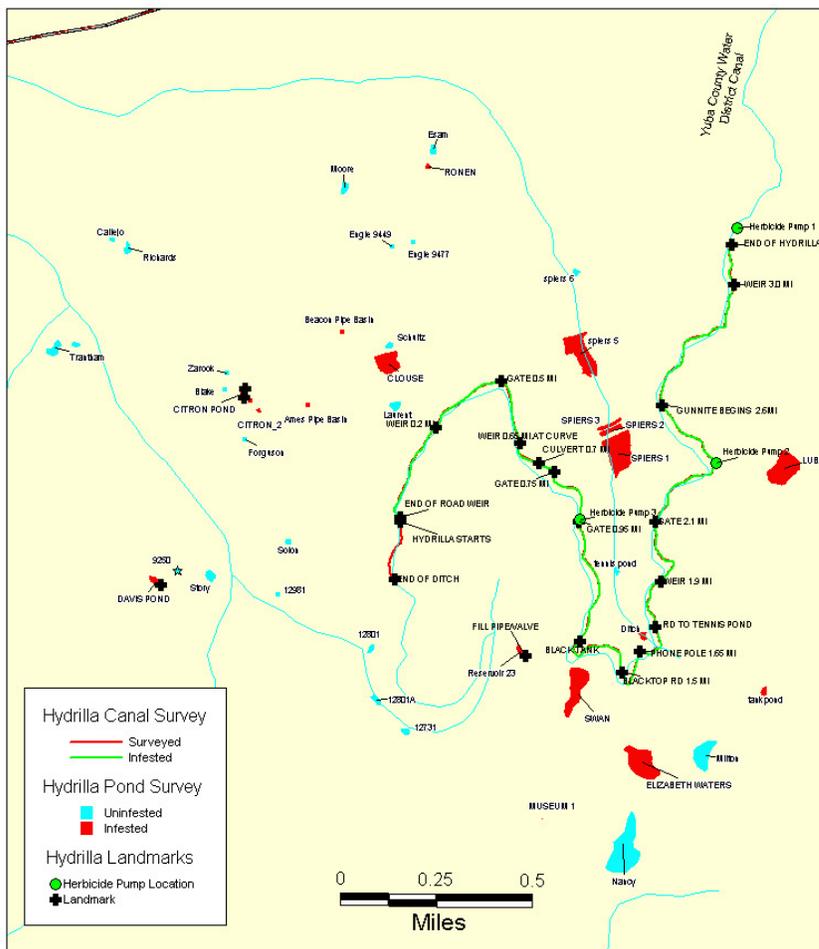
### Plate 13. Hydrilla Infested Ponds near Oregon House, and Hydrilla Infested Portion of Yuba County Water District Canal

#### Oregon House Hydrilla Eradication Project, Yuba County

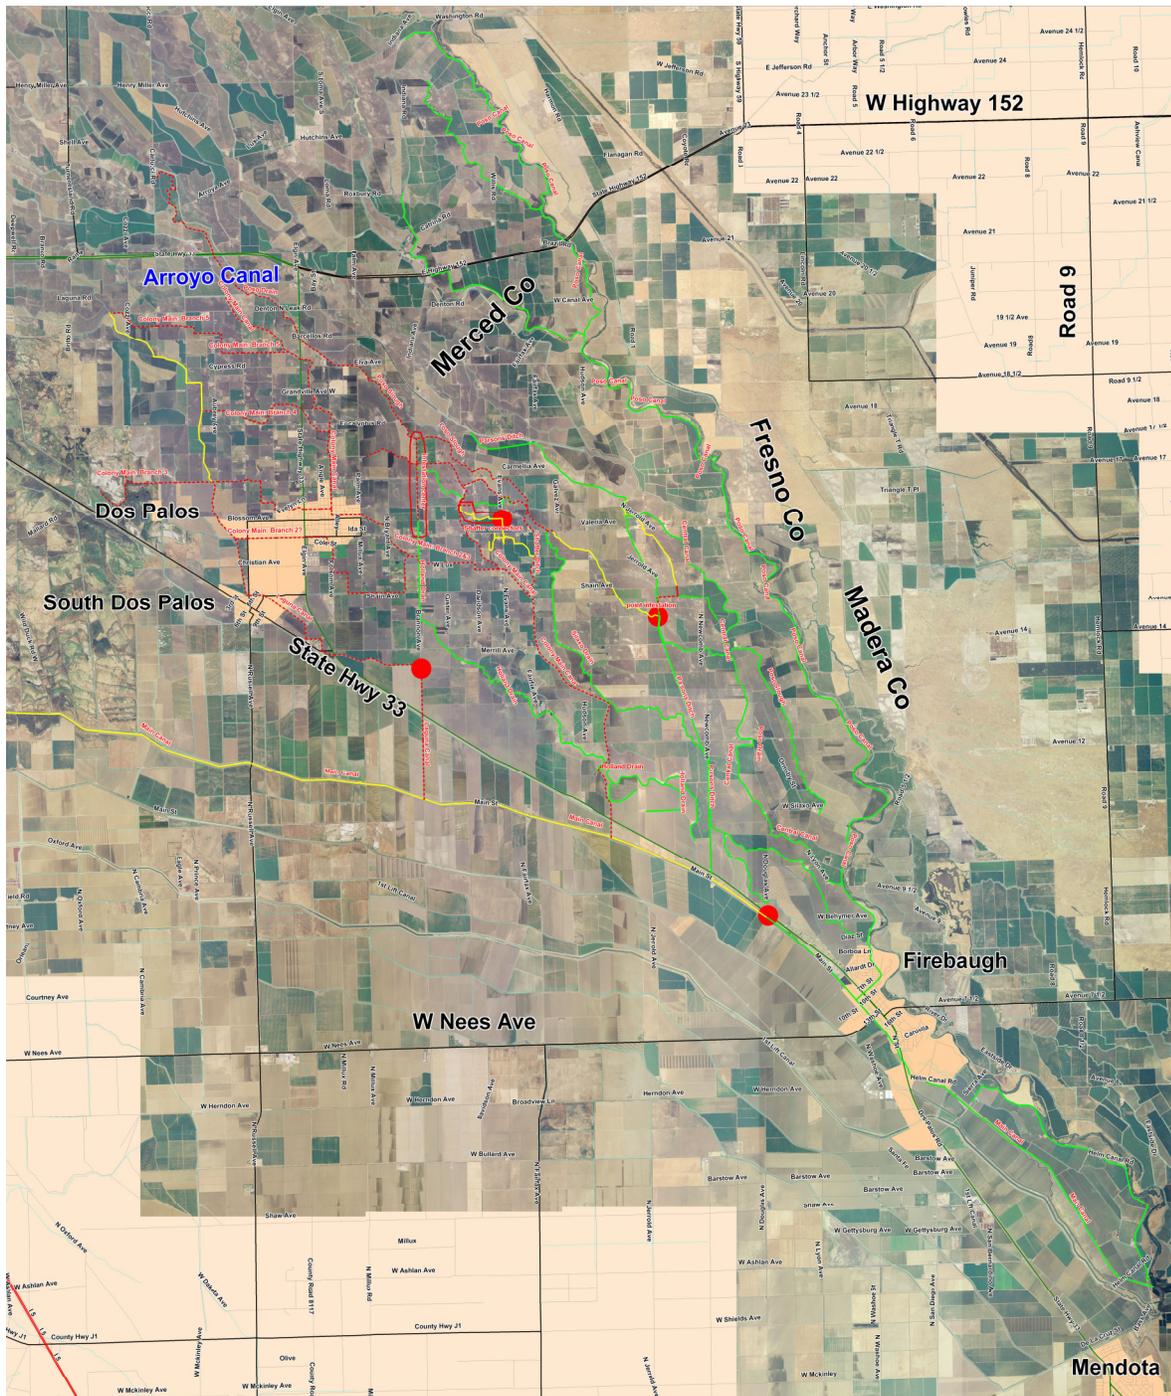
# Plate 14: Spongeplant in the area of western Fresno County

Infestation Levels	
— (Red line)	local heavy (1)
— (Green line)	no plants (124)
— (Yellow line)	none; downstream of infested (33)
— (Dotted line)	scattered (151)

South American spongeplant survey in irrigation canals in the west-central section of the San Joaquin Valley, California
