**THE CALIFORNIA DEPARTMENT OF FOOD AND AGRICULTURE
HYDRILLA ERADICATION PROGRAM
ANNUAL PROGRESS REPORT 2011**

PROTECTING CALIFORNIA'S WATERWAYS

Prepared by Patrick Akers, Supervising Scientist,
with the assistance of Program Staff

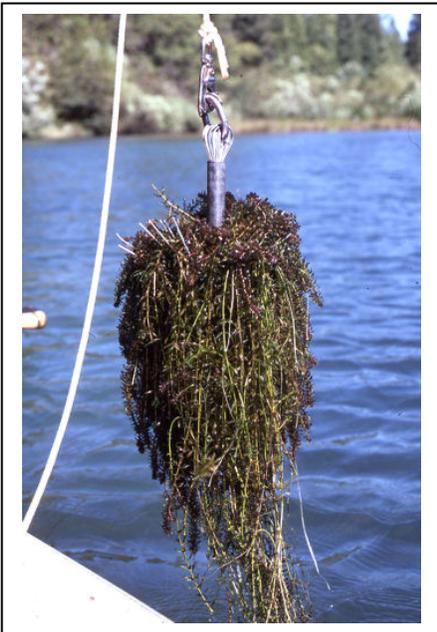
Plate 1. The “hydrilla hook”, a small grappling hook, with hydrilla

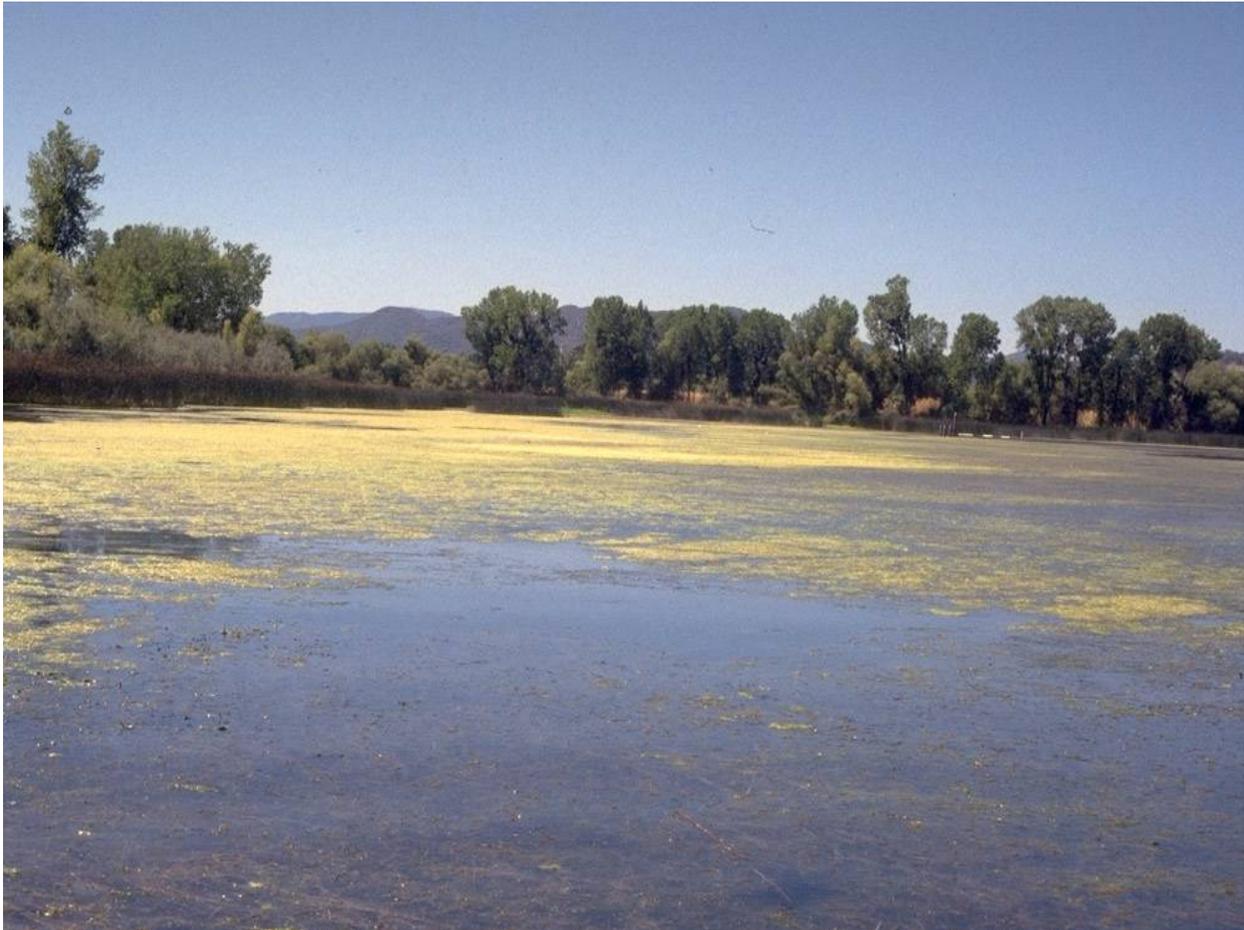
Plate 8: Hydrilla in Clear Lake, 1994, in the area of Big Valley, before treatments started.

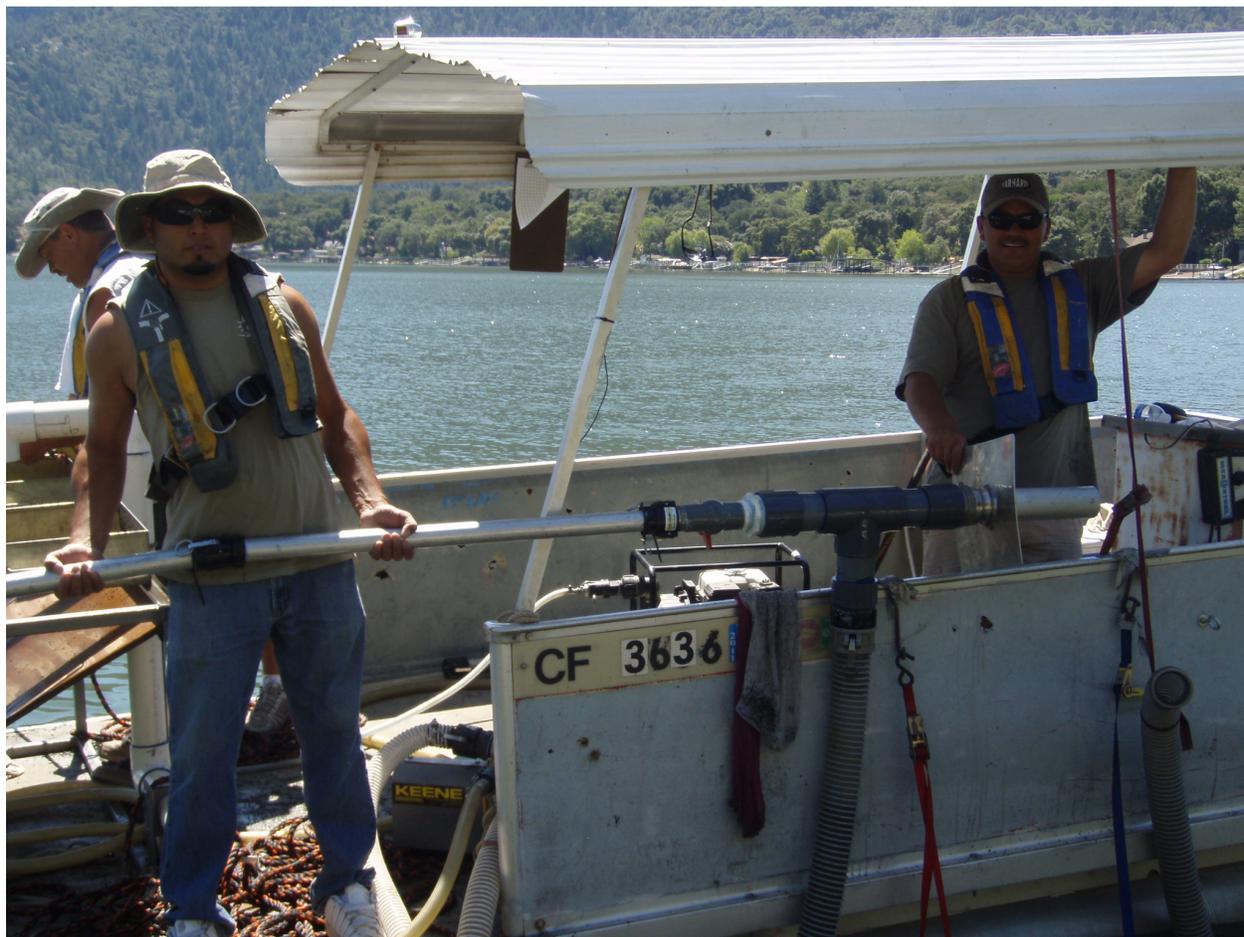
Plate 15: The sampling head for the dredge-based sediment core sampler. The head is the aluminum tube on the right. Just to the left of the tube, being held by the crew person, is the square plate that limits the depth the core head can sample. To the left of that, the suction tube leading to the dredge leads off the sampler at a right angle. The crew person in the sunlight holds the sampler up by its handle, which can be adjusted in length for different water depths.

modifying a standard venturi-type, small hydraulic gold dredge to take core samples. After a variety of modifications, we created a sampler that could create approximately 4-inch by 12-inch core samples (Plate 15). We washed the samples through 3/16-inch screen and visually searched the material retained by the screen for tubers. The core sampler commonly brought up tubers of sago pondweed, fragile snail shells, seed pods of cocklebur, damselfly nymphs, and even small fish upon occasion, almost all undamaged. Previous work in other eradication projects used gold dredges, and had no problem collecting tens of thousands of tubers. Therefore the method should have collected any hydrilla tubers without seriously damaging them. The core sampler and screens were mounted on a pontoon boat to provide a work platform (Plates 15, 16).

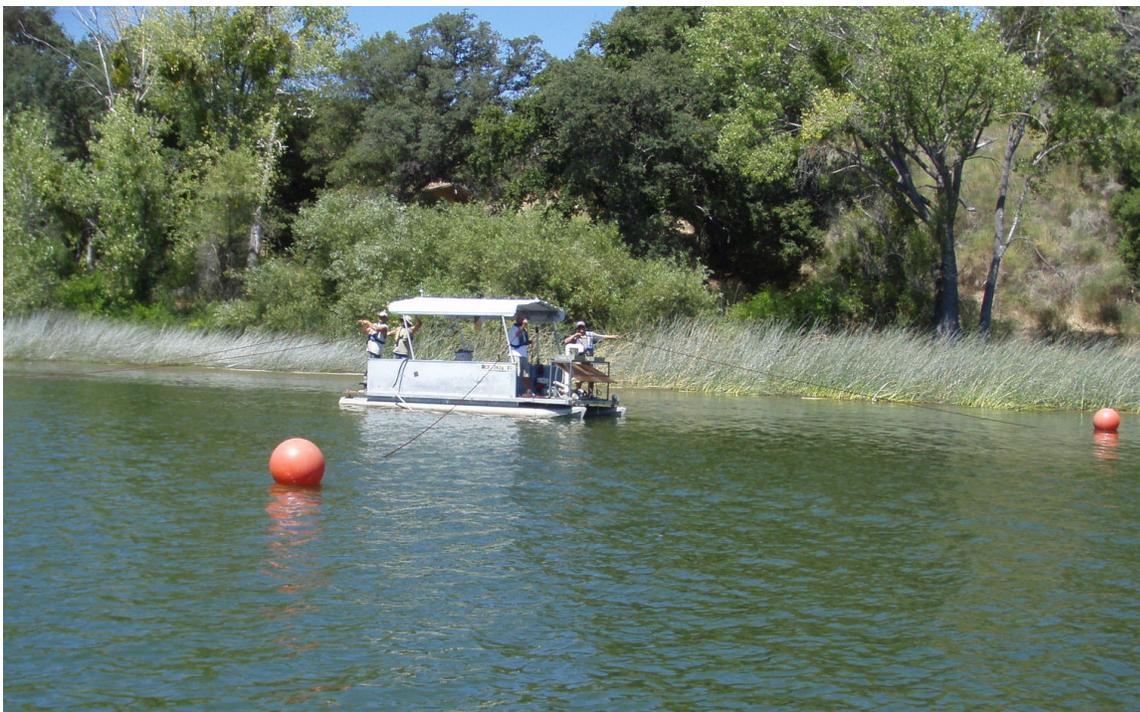
Plate 16: The sampling pontoon boat, showing the lines running from four corners of the platform to the anchors (marked by orange buoys).

In order to fix the location of the work boat in the lake while taking core samples, we placed 180-pound anchors at the four corners of a rough quadrangle surrounding or within one of the candidate high-density plant sites. The anchors were spaced 50-150 feet apart, and a rope ran from each one to a separate corner of the pontoon boat. To remain on a core sampling site, the ropes were pulled snug from each corner to its anchor (Plate 16). At such a core sampling site, five core samples were taken along one of the long sides of the pontoon boat, at intervals of approximately three to four feet. The pontoon boat was moved from one core sampling site to the next by adjusting the lengths of the ropes to the anchors. The boat could then progressively cover the area.
