A new invader

South American spongeplant: worse than water hyacinth?

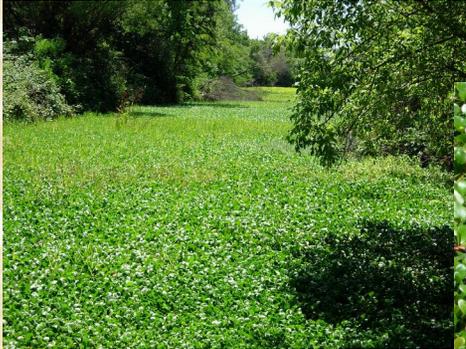
Above: The first California infestation, found in a 5-acre Redding pond in 2003, seen here before treatment. The spongeplant choked out the parrotfeather and most of the water primrose that was in the pond. In the middle distance, some remaining primrose is barely visible, and beyond that, grass is starting to grow on the spongeplant mat. Right: a close-up of the infestation. The white square is 0.5m (20 inches) on a side.

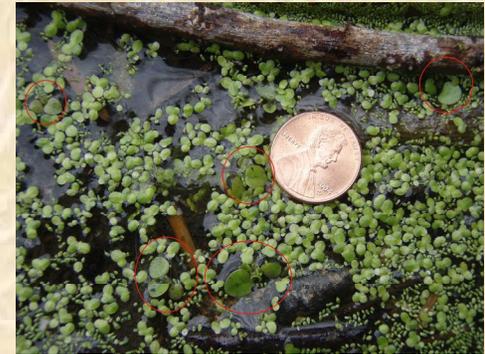
Right: spongeplant mixed in with duckweed and watermeal. The red ellipses circle spongeplant seedlings.

Water hyacinth reproduces from seed very rarely, but spongeplant produces many seeds and seedlings. Our observations indicate that it flowers heavily as the weather warms in May and June, but flowers can be found throughout the growing season. Mature seeds are about the size of peppercorns. We found no information in the scientific literature on how long seeds survive, but our experience suggests it is at least three years. If we begin treating an infestation that has existed for several years and has had time to set seed, we still find new seedlings even after three years of treating. During that time, we allow few if any plants to set seed.

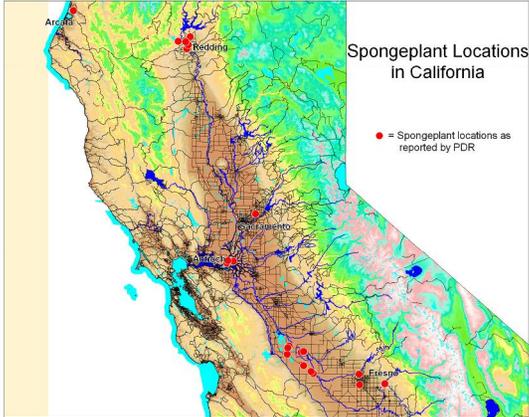
Above: Official state records of spongeplant locations in California. The first records of spongeplant were in 2003, in Arcata and Redding. No more spongeplant appeared until the summer of 2007, when plants were reported in the San Joaquin River in Fresno. In late December, 2007, it was found a few miles from Antioch in a patch at the western edge of the Delta. That patch seemed to disappear after a major winter storm occurred a few days after the report. In winter of 2008, plants were found in a canal system off the Kings River east of Fresno. In summer, 2008, it appeared in canals in western Fresno County between Mendota and Dos Palos. In 2009 and 2010, it was again found in the Delta. The Sacramento city location was in a small drain and has been eradicated.

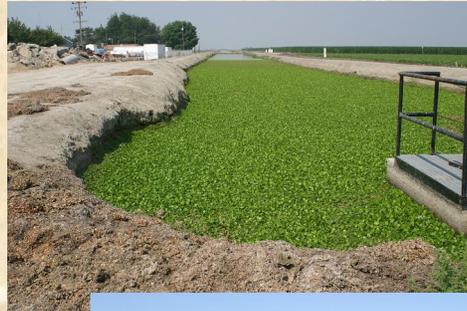
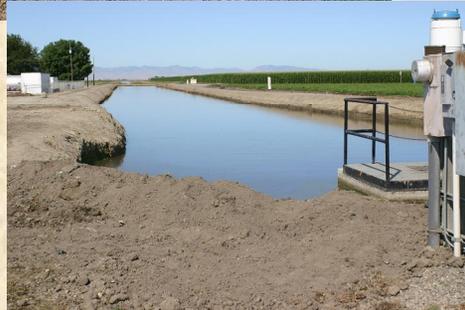
Above, top: Spongeplant in a canal in western Fresno County, near South Dos Palos. Above, bottom: the same canal two weeks later, after treatment. Although spongeplant spreads easily, it is relatively easy to control by mechanical removal or herbicides, at least in situations where it hasn't developed a seed bank.

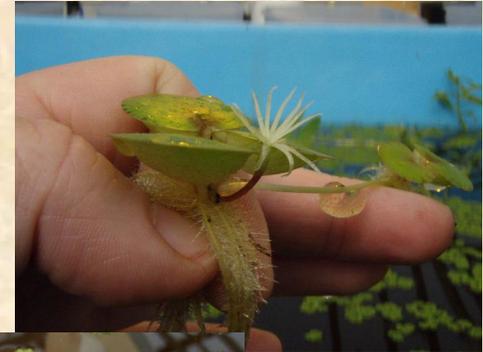
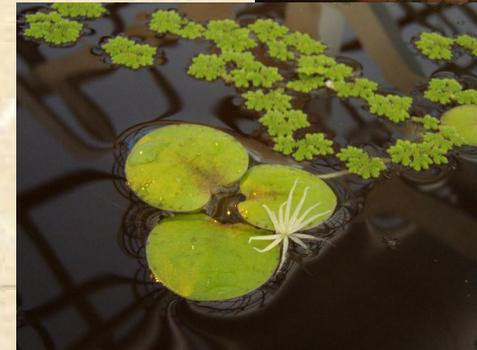
Right: spongeplant has a distinctive leaf profile in plants that grow in uncrowded conditions. When uncrowded, spongeplant leaves lie flat on the water (right, below) and have a strongly keeled profile (right). The lower surface of the leaf has a large number of air-filled chambers (aerenchyma) that help it float. In crowded conditions (photos left and above), the leaves turn upright, the leaf stems elongate, and the leaves thin and expand. In crowded conditions, spongeplant is easily mistaken for water hyacinth.

The long pale filaments of the star-shaped female flower are easy to see in these photos. Male and female flowers occur on the same plant, but male flowers do not stand out and are hard to find.
